BEFORE THE HON'BLE NATIONAL GREEN TRIBUNAL

ORIGINAL APPLICATION NO. 65 OF 2016

Affidavit on behalf of Respondent No. 3 for submission of suggestions/objections to the report dated 28th July 2016 filed by the Principal Committee

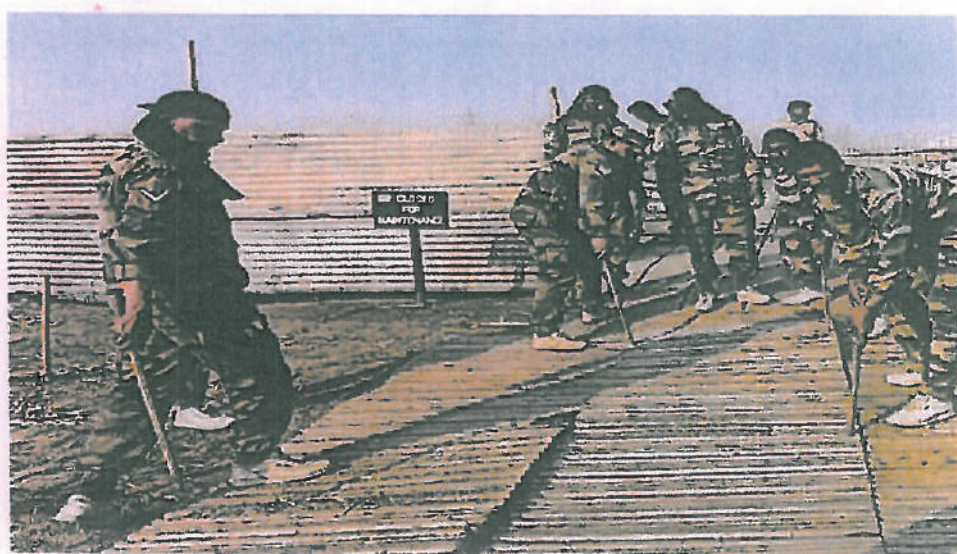
Photo - 2: Laying of Pontoon bridges across Yamuna by trained professionals note the ramps are made-up of wooden 'approach slab' and corrugated metal sheet and not of debris and stone grit as claimed by the Principal Committee.

Photo - 1: Laying of Pontoon bridges across Yamuna by trained professionals note the ramps are made-up of wooden 'approach slab' and corrugated metal sheet and not of debris and stone grit as claimed by the Principal Committee.

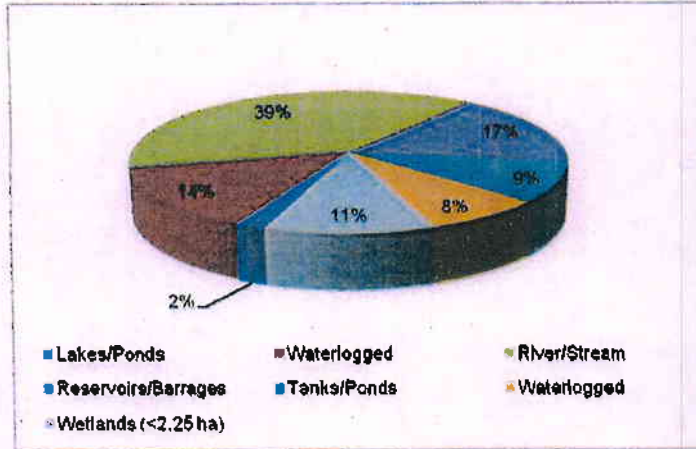
Figure 25: Type-wise wetland distribution in Delhi

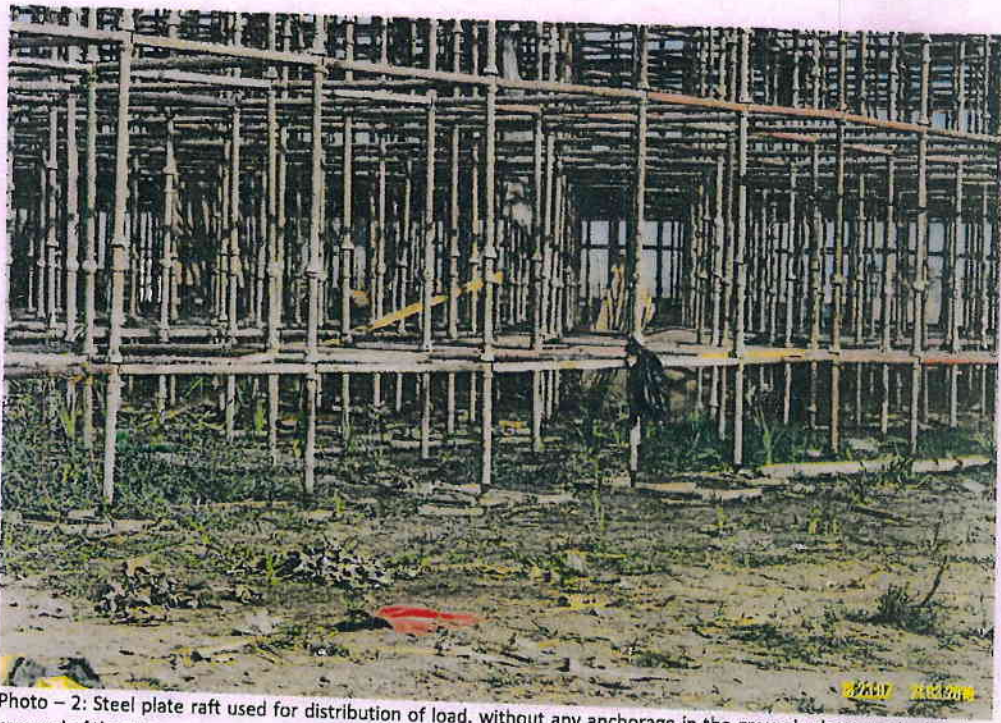
Photo - 2: Steel plate raft used for distribution of load, without any anchorage in the ground; photographed during removal of the stage.

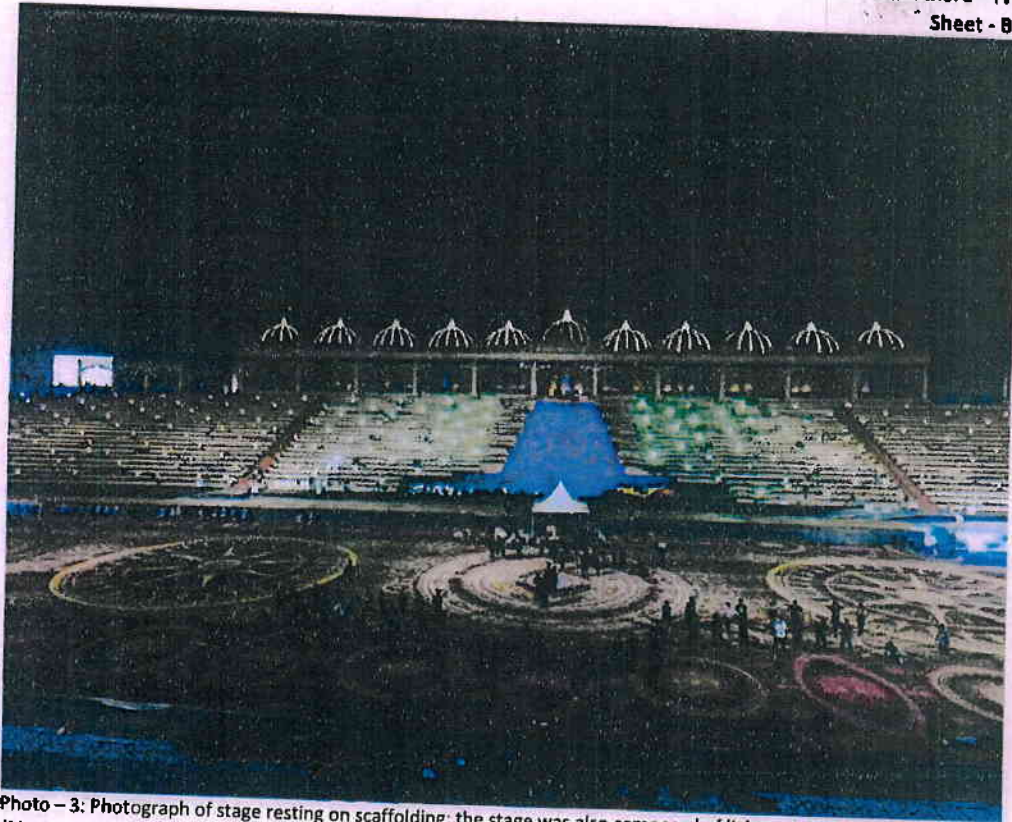
Photo - 3: Photograph of stage resting on scaffolding; the stage was also composed of light weight material.
(Photograph Sourced from Public Domain)
