EXPERT REPORT OF Mr. RAKESH RANJANSCOPE:

1. The scope of present study is to conduct a scientific examination of claims and counterclaims of irreversible and/or reversible damages to a land parcel on floodplain of Yamuna due to Art of Living's event, World Culture Festival 2016 which was held between 11<sup>th</sup>, 12<sup>th</sup> and 13<sup>th</sup> of March 2016 (hereinafter referred to as "**Land Parcel**"). This Land Parcel can be delineated over a satellite imagery dated between 10<sup>th</sup> and 17<sup>th</sup> of March 2016 with all its installations and temporary (or permanent) infrastructure. The Land Parcel in this case is a finite portion of land over Yamuna floodplain bound by DND Flyway to its South; Barapullah Drain to its North; River Yamuna to its East and Ring Road to its West and more precisely the core area of activity has been marked over a high resolution satellite imagery available in public domain on google earth, dated 15<sup>th</sup> of March 2016 and it can be located by WGS 84 coordinates 28°34'55"N and 77°16'43"E [screenshot and interpretation are enclosed in **Annexure – I(Colly)**].

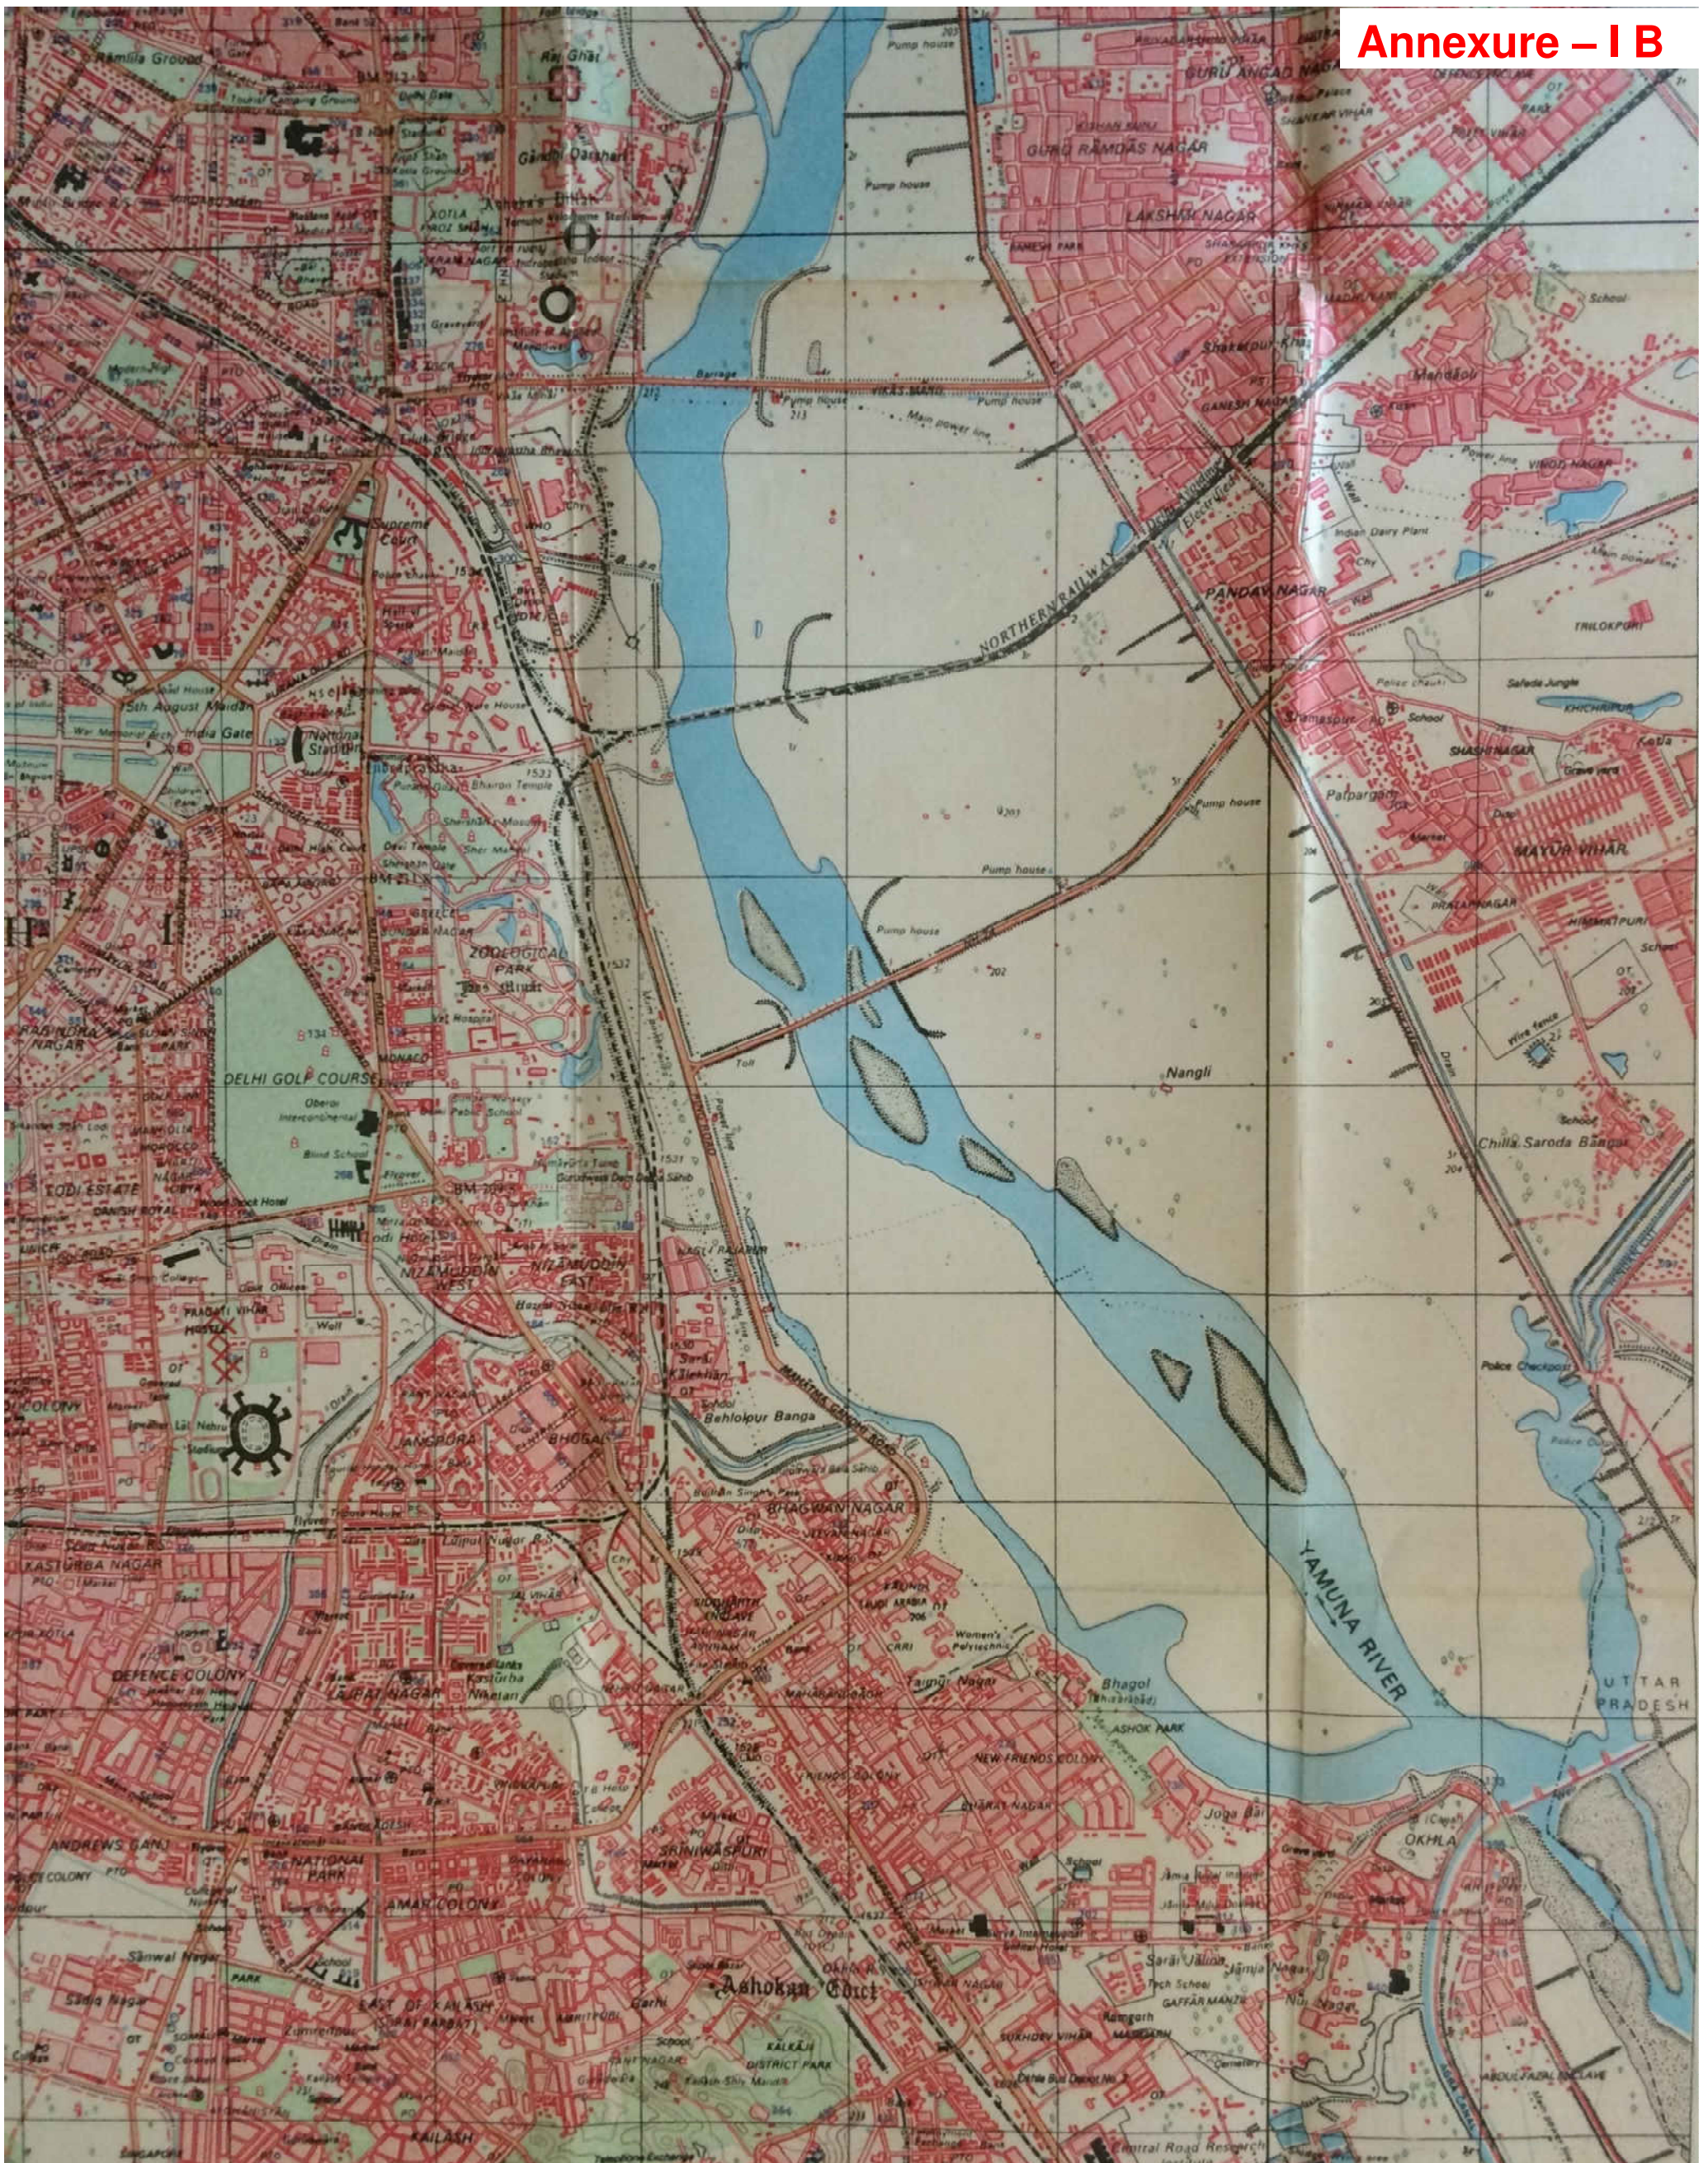
Annexure – I B: A Portion of 1:25000 Scale Detailed Map of Delhi; Published by Survey of India in Year 1985, Under the Direction of Major General Girish Chandra Aggarwal, Surveyor General of India; Titled – “Delhi Guide Map, Third Edition 1985”.

The map clearly depicts the WCF 2016 event site as an extremely flat “Point Bar” (floodplain deposit) without existence of any wetland or enclosed waterbody. The flatness of this land parcel is to the extent that contour indicating difference in height of the order of 100cm is also non-existent throughout the area.

Another important point for record in this map is the existence of natural path of ‘Kushak River – Barapullah Drain’ prior to straightening of its channel traversing straight into River Yamuna and filling of its original channel. The map also depicts the situation prior to construction of Guide Bank and DND Flyway.

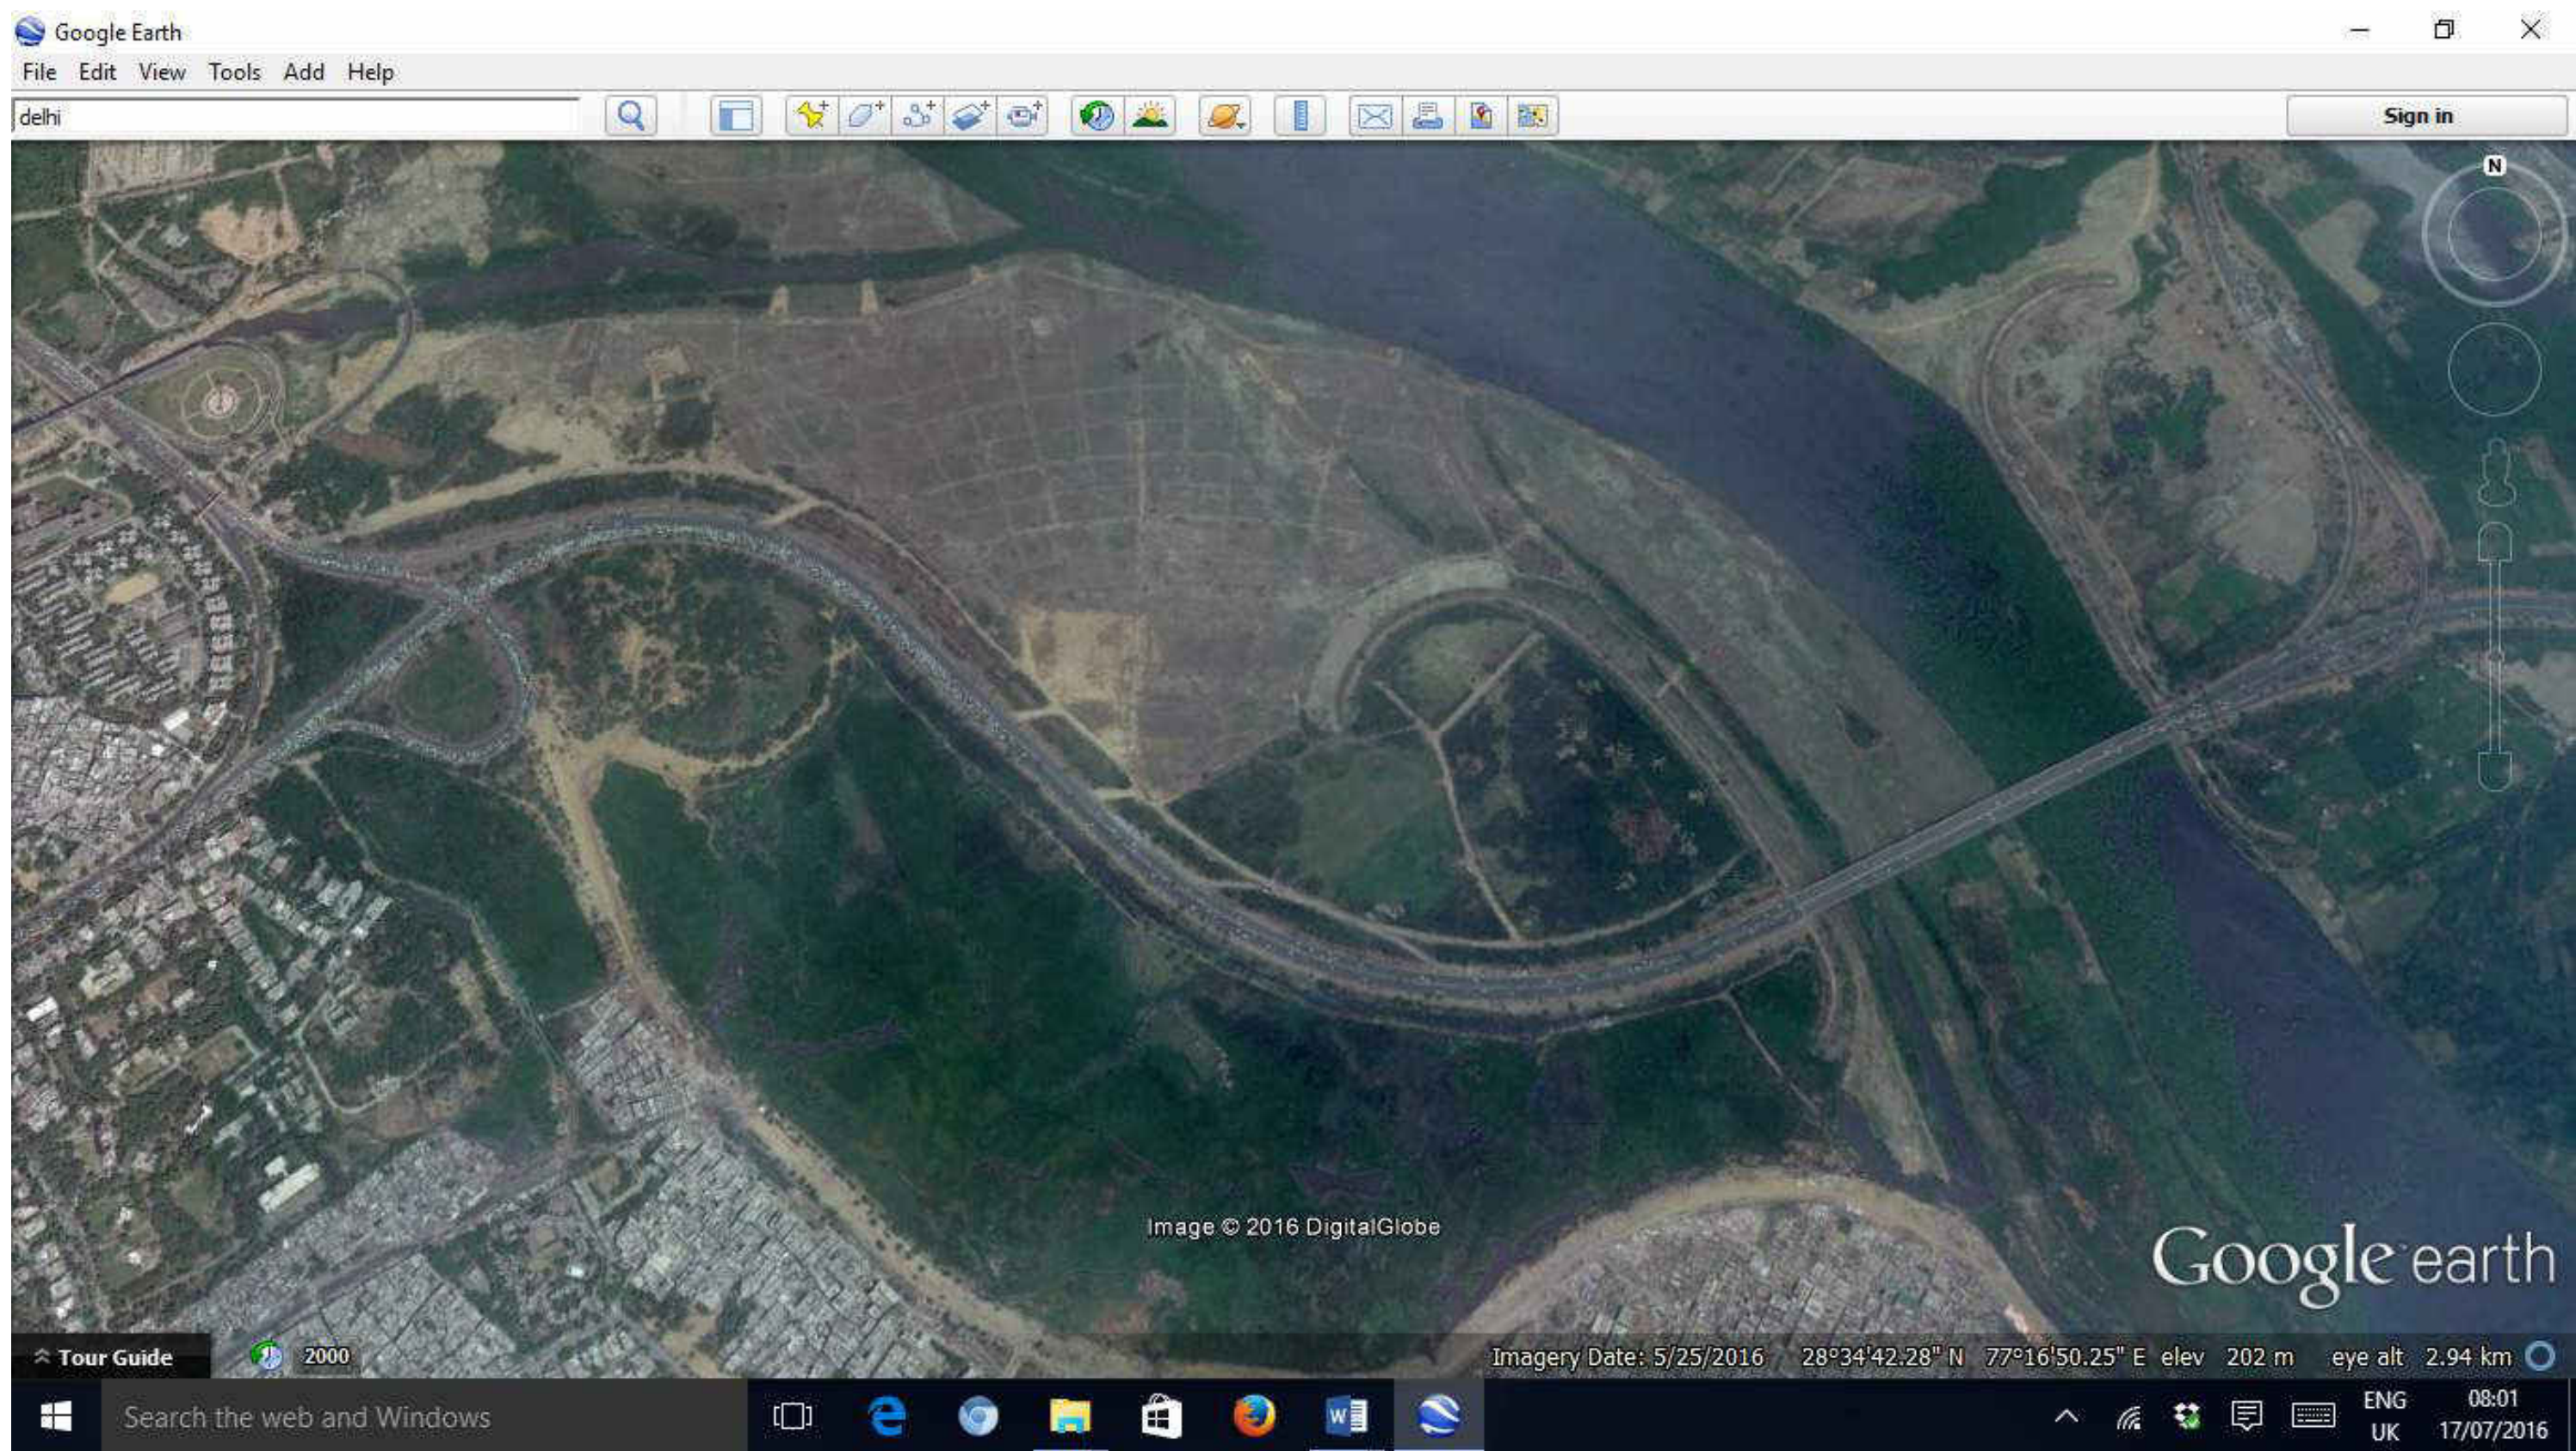
Screen shot of satellite image dated 25/05/2016 depicting entire area utilised for the World Culture Festival 2016 event (Now evacuated, cleared, and all the temporary installations removed).

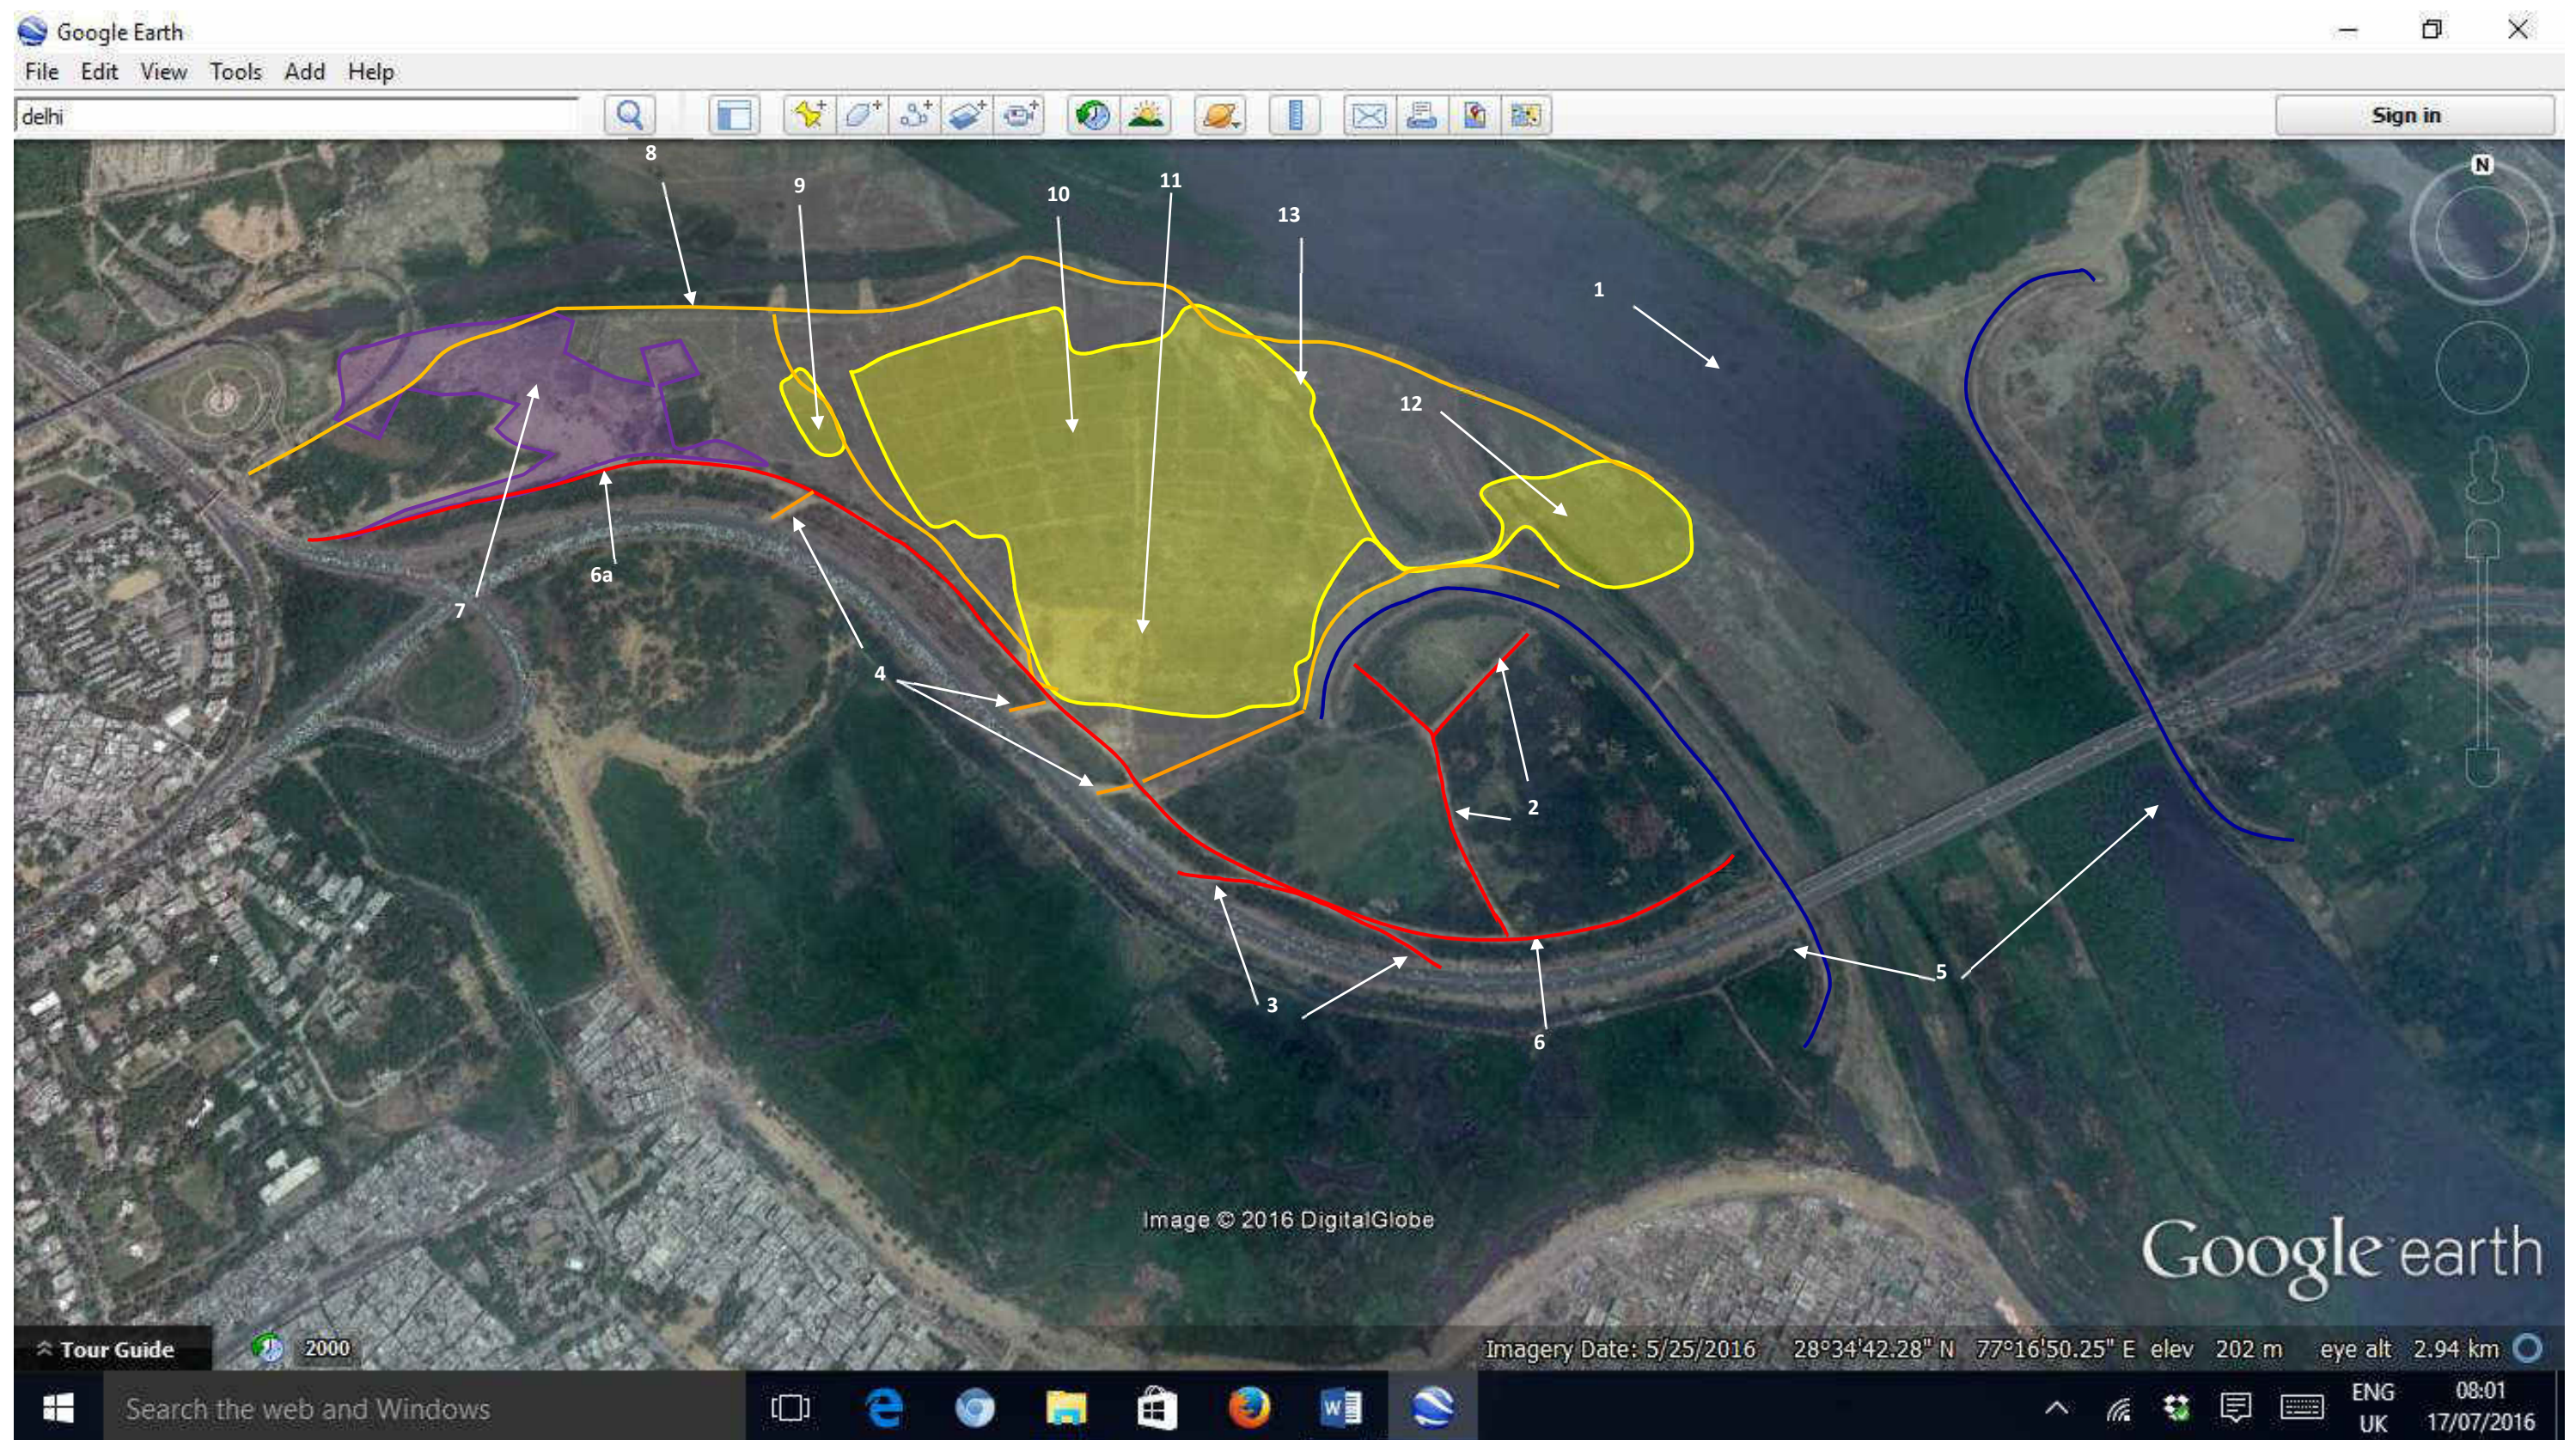
Satellite Image dated 25/05/2016 depicting entire area utilised for the World Culture Festival 2016 event (Now evacuated, cleared, and all the temporary installations removed):

1. River Yamuna flowing as usual	8. Unpaved earthen road running parallel to Barapullah Drain, which is in existence at least since Year 2000, used for vehicles and earthmovers engaged in drain cleaning, sludge and silt removal in this section of Barapullah Drain.

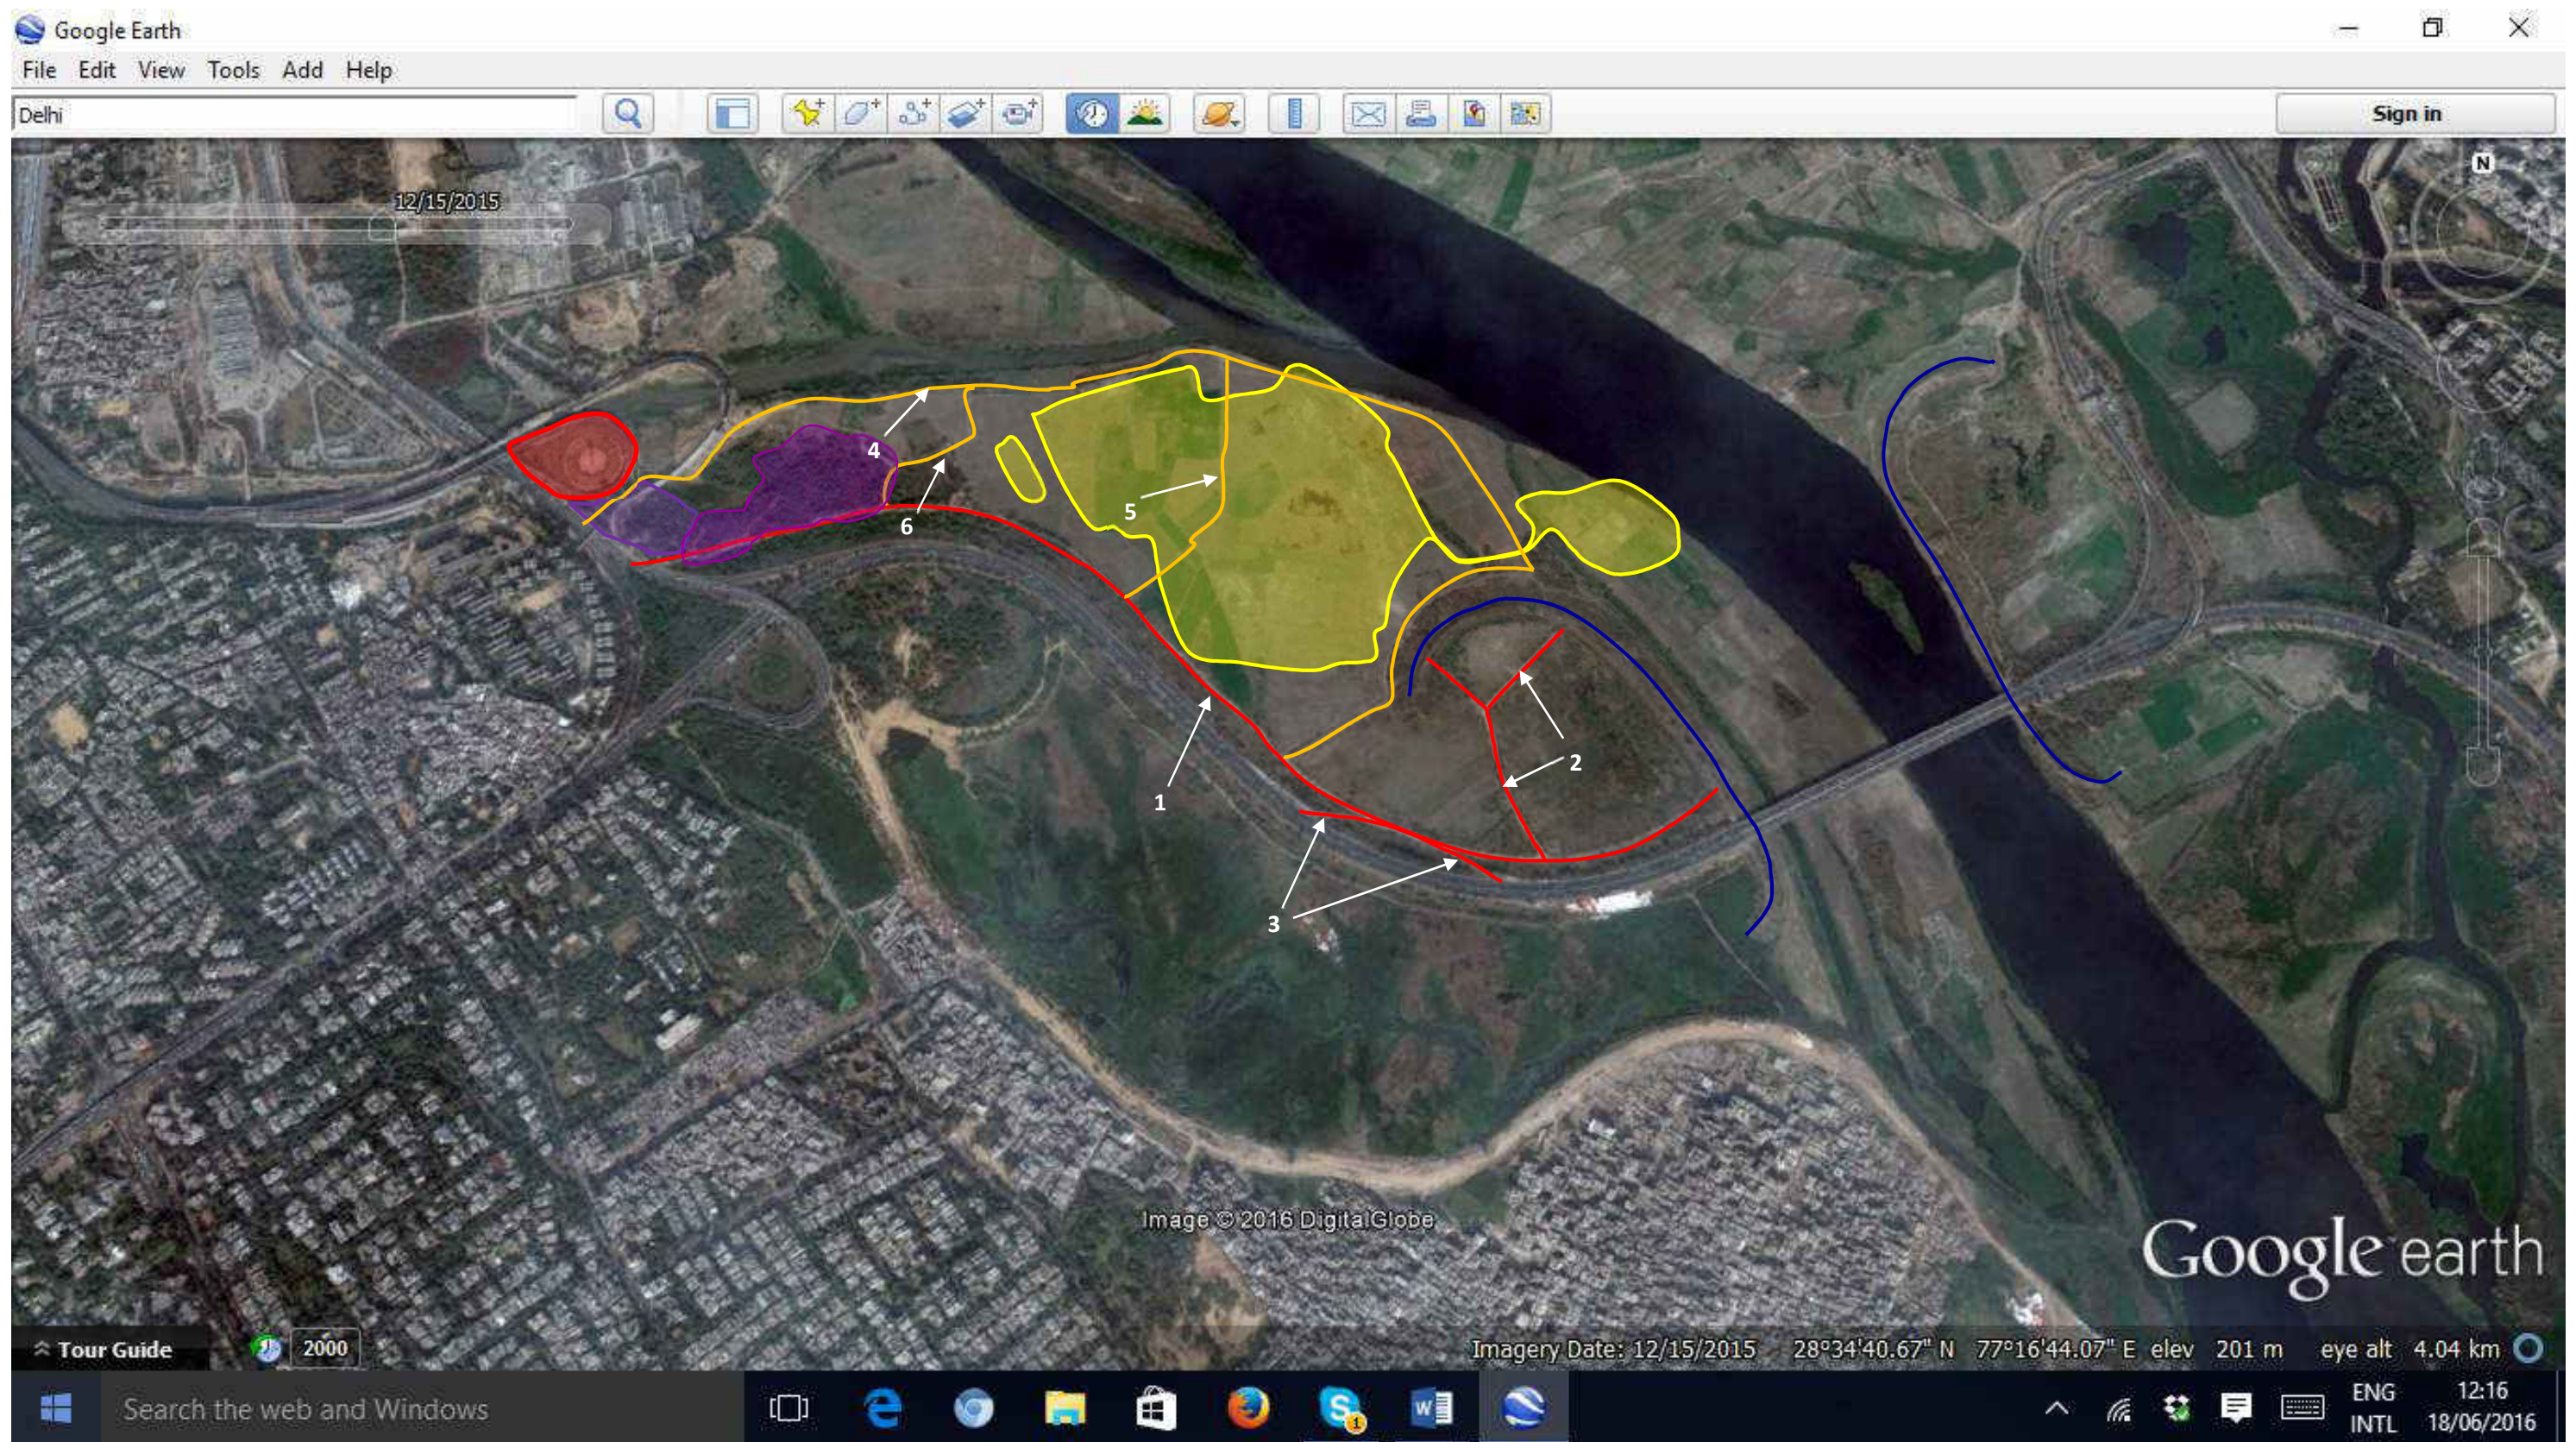
**Image Date 15/12/2015 (Post-monsoon); Depicting Extremely Flat Point Bar (Deposit of Fluvial Sand) with Clear Landuse Pattern; Open Agricultural Plots with Patches of Crop and Harrowed Open Field; Sandy Soil with Reasonably Good Soil Moisture; No Undulation or Waterbody/Wetland in Existence Over Point Bar.**

Arrow Pointed Observation: (1) Gravel Road (Now Partially paved by bituminous Overlay) parallel to DND Flyway. This earthen road was initially constructed to facilitate construction of DND flyway; movement of earthmovers and construction vehicles etc. This road is in existence since then and is still in use for movement of farm equipment (tractors); construction industry vehicles like dumpers, loaders and trucks etc.

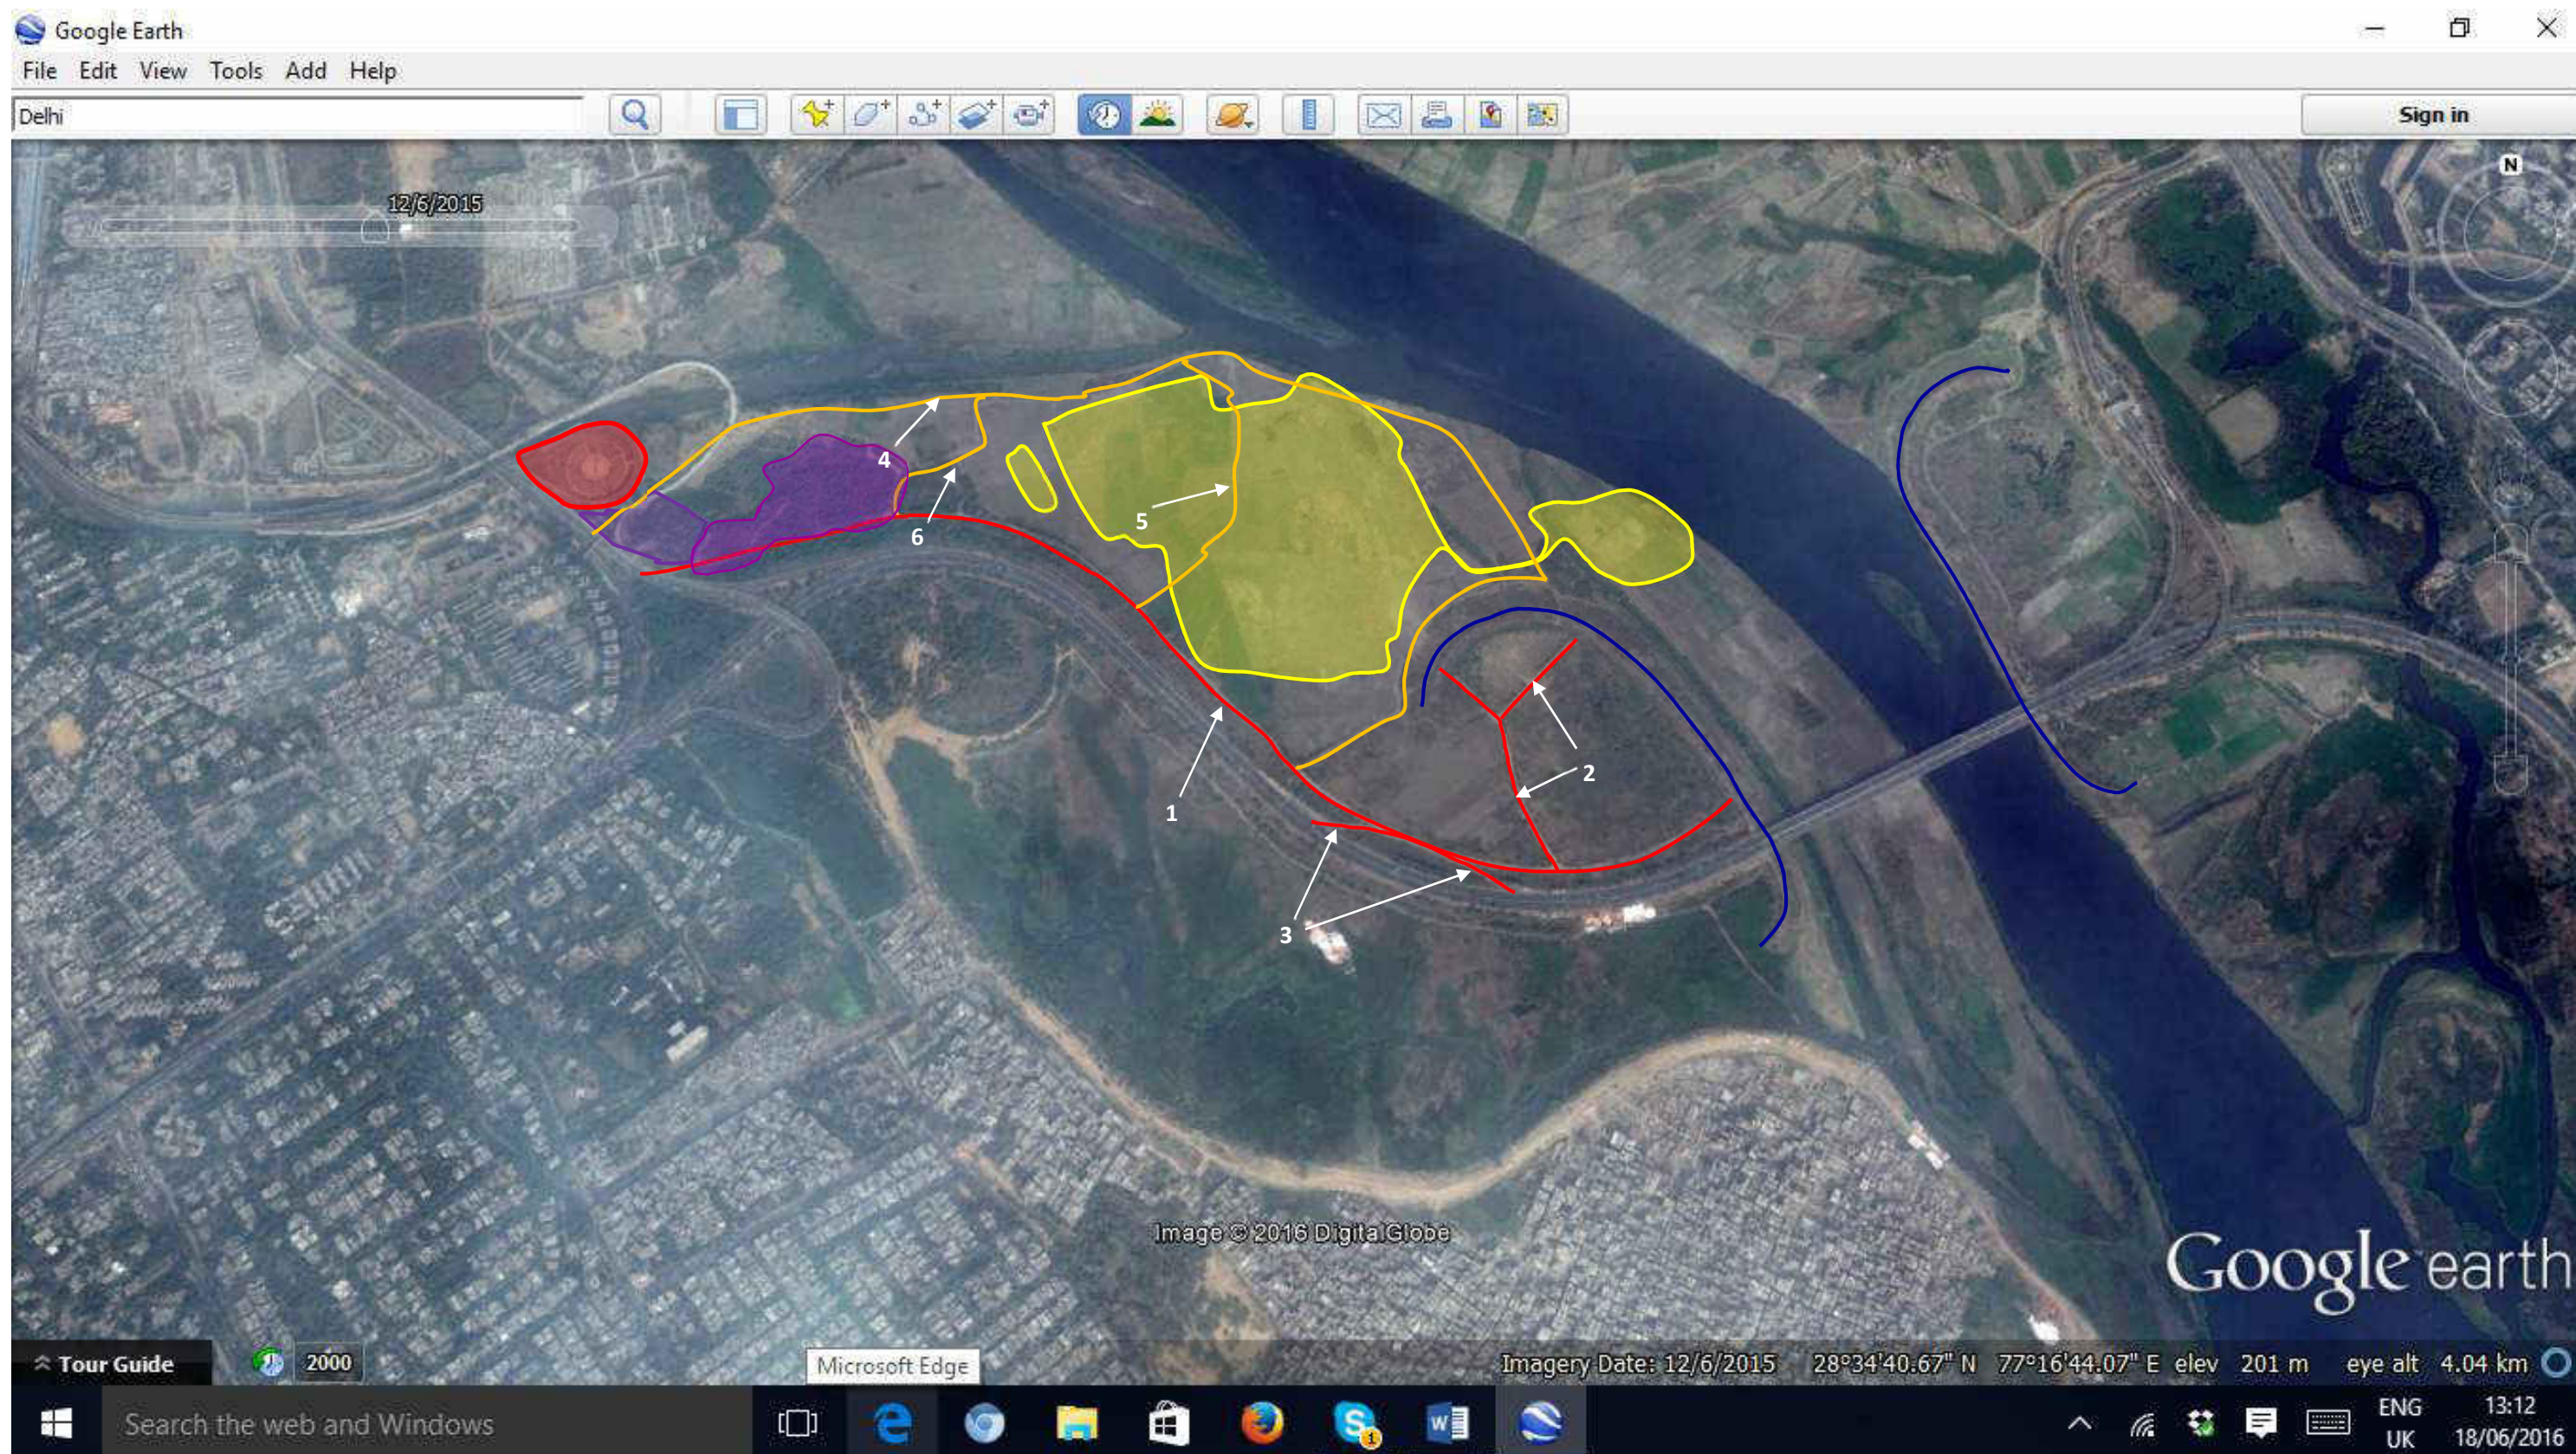
**Image Date 06/12/2015 (Post-monsoon); Depicting Extremely Flat Point Bar (Deposit of Fluvial Sand) with Clear Landuse Pattern; Open Agricultural Plots with Patches of Crop and Harrowed Open Field; Sandy Soil with Reasonably Good Soil Moisture; No Undulation or Waterbody/Wetland in Existence Over Point Bar.**
