EXPERT REPORT OF Mr. RAKESH RANJANSCOPE:

1. The scope of present study is to conduct a scientific examination of claims and counterclaims of irreversible and/or reversible damages to a land parcel on floodplain of Yamuna due to Art of Living's event, World Culture Festival 2016 which was held between 11<sup>th</sup>, 12<sup>th</sup> and 13<sup>th</sup> of March 2016 (hereinafter referred to as "**Land Parcel**"). This Land Parcel can be delineated over a satellite imagery dated between 10<sup>th</sup> and 17<sup>th</sup> of March 2016 with all its installations and temporary (or permanent) infrastructure. The Land Parcel in this case is a finite portion of land over Yamuna floodplain bound by DND Flyway to its South; Barapullah Drain to its North; River Yamuna to its East and Ring Road to its West and more precisely the core area of activity has been marked over a high resolution satellite imagery available in public domain on google earth, dated 15<sup>th</sup> of March 2016 and it can be located by WGS 84 coordinates 28°34'55"N and 77°16'43"E [screenshot and interpretation are enclosed in **Annexure – I(Colly)**].

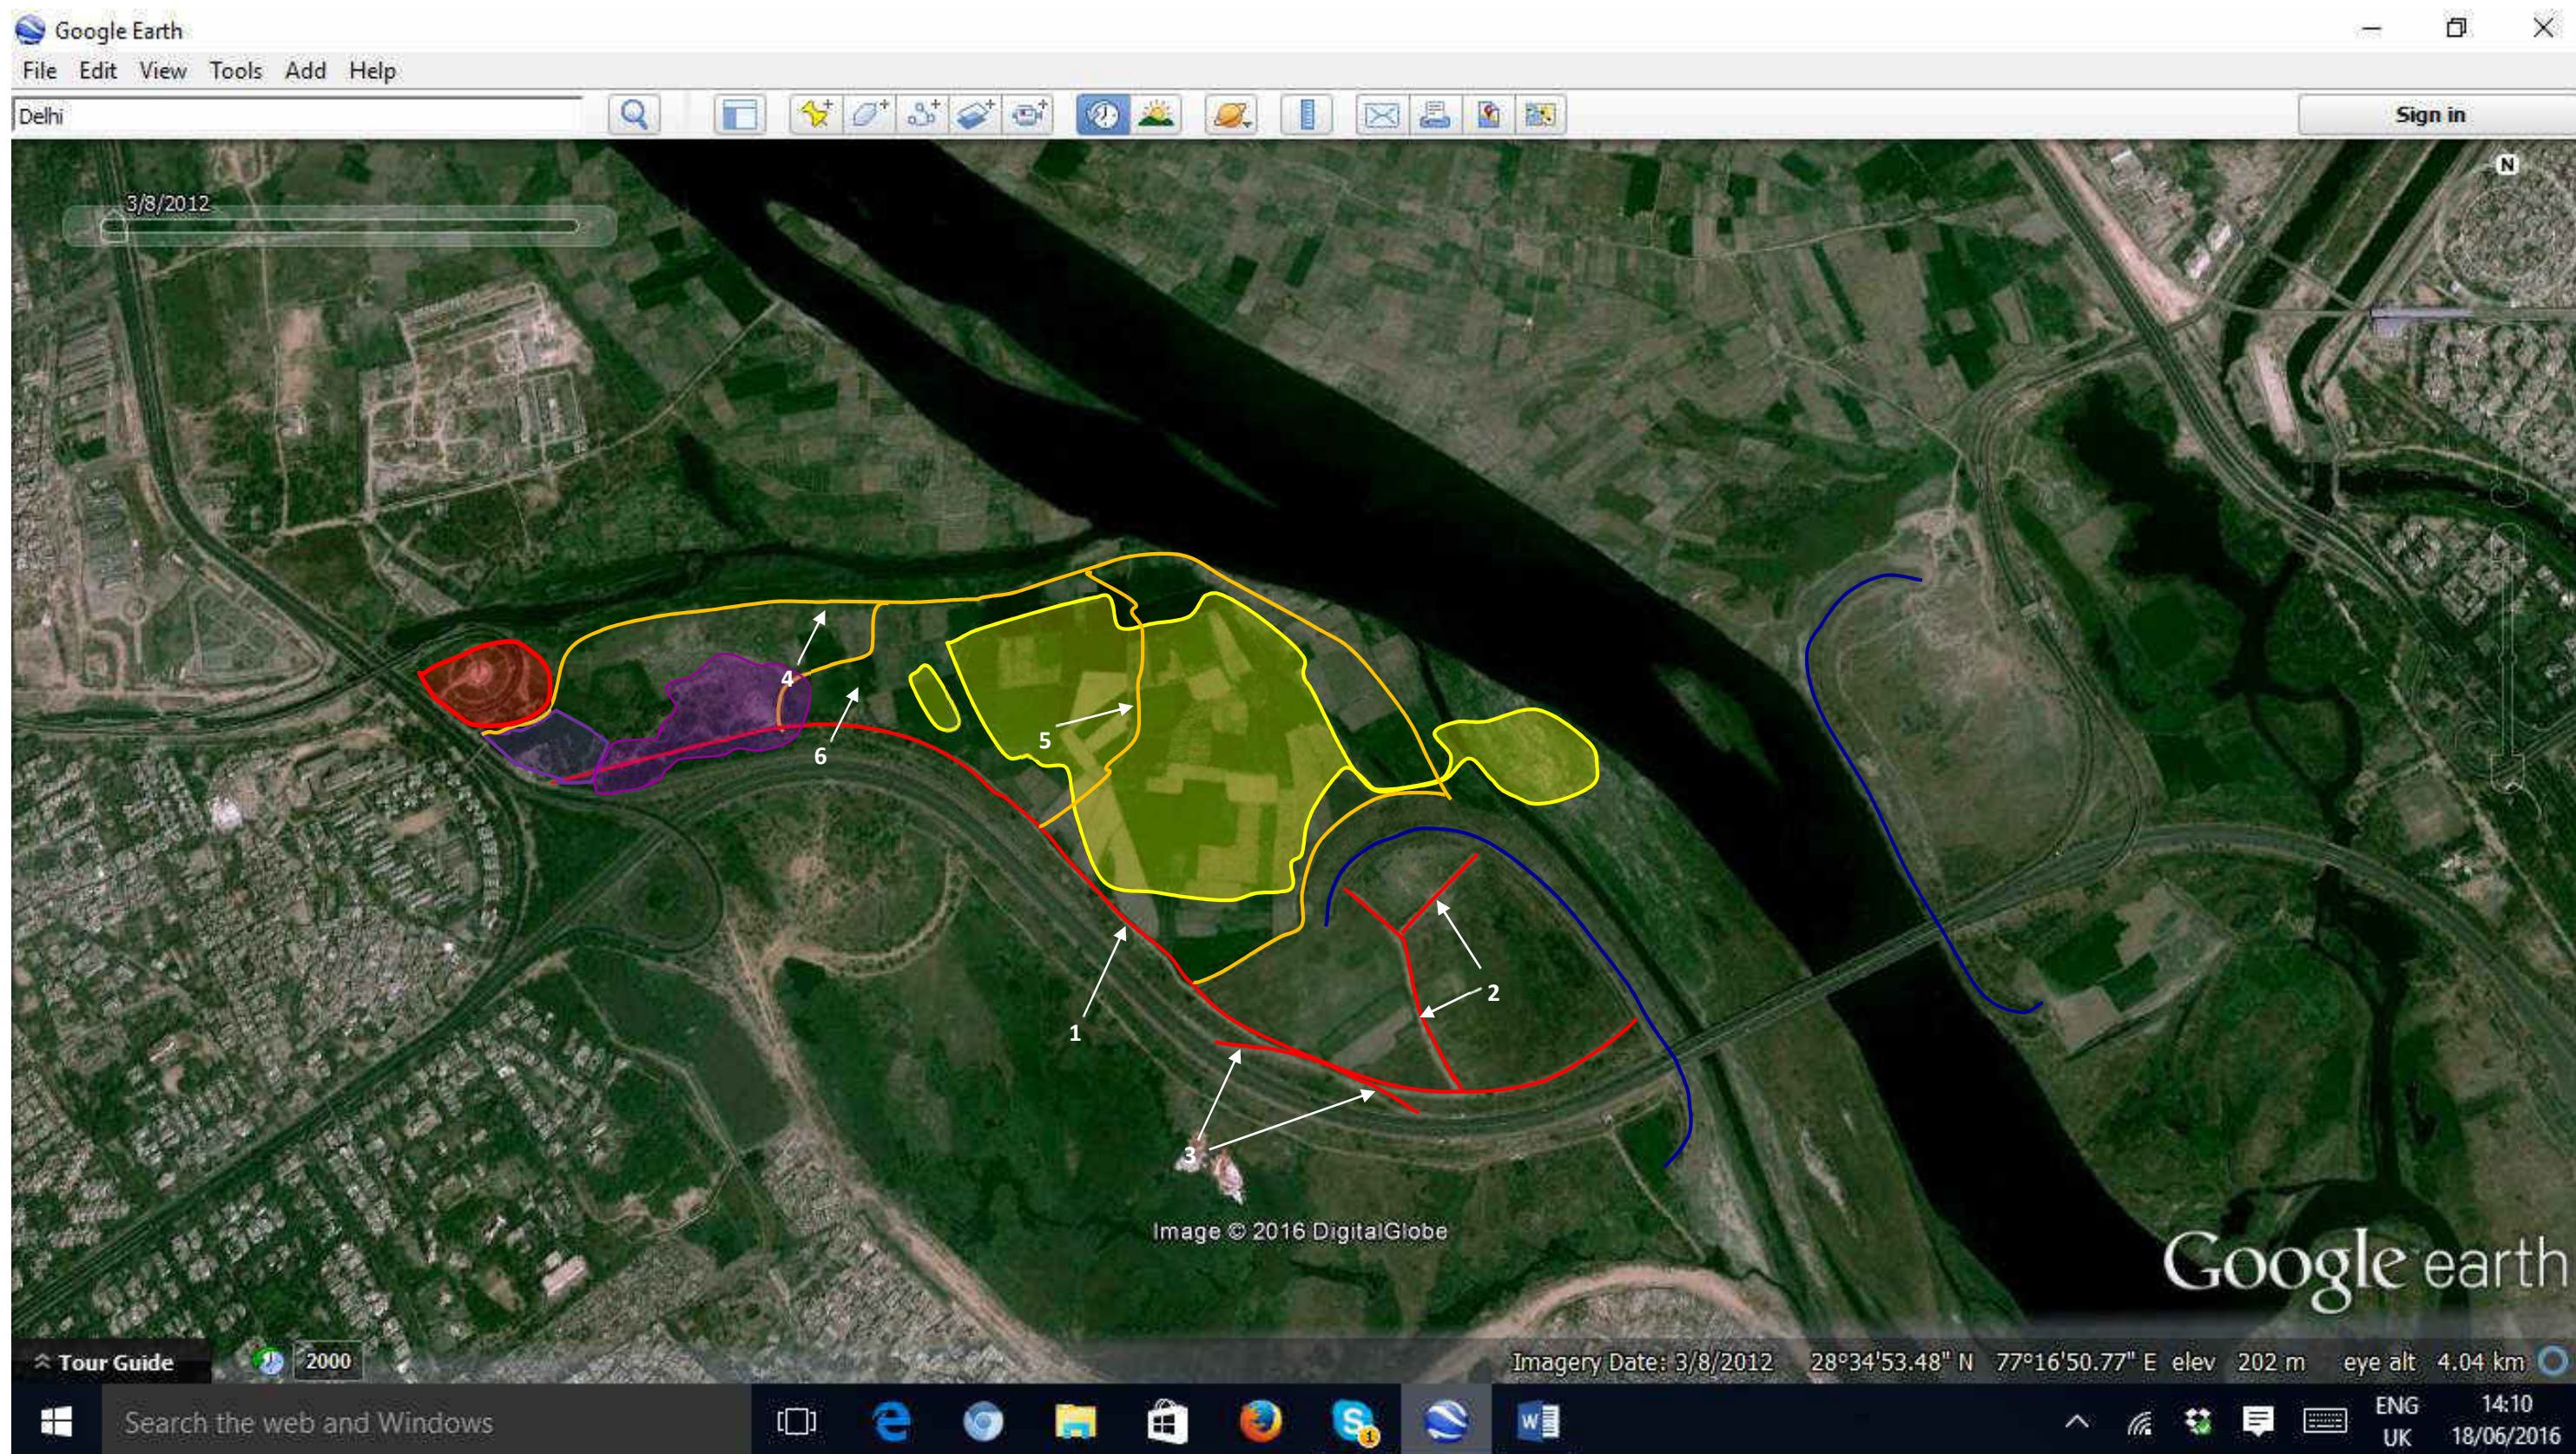
**Image Dated 08/03/2012 (Pre-monsoon); Depicting Cloudy Weather Over Extremely Flat Point Bar (Deposit of Fluvial Sand) with Clear Landuse Pattern; Open Agricultural Plots with Patches of Crop and Open Field; Sandy Soil with Reasonably Good Soil Moisture; No Undulation or Waterbody/Wetland in Existence Over Point Bar.**

Arrow Pointed Observation: (1) Gravel Road (Now Partially paved by bituminous Overlay) parallel to DND Flyway. This earthen road was initially constructed to facilitate construction of DND flyway; movement of earthmovers and construction vehicles etc. This road is in existence since then and is still in use for movement of farm equipment (tractors); construction industry vehicles like dumpers, loaders and trucks etc.

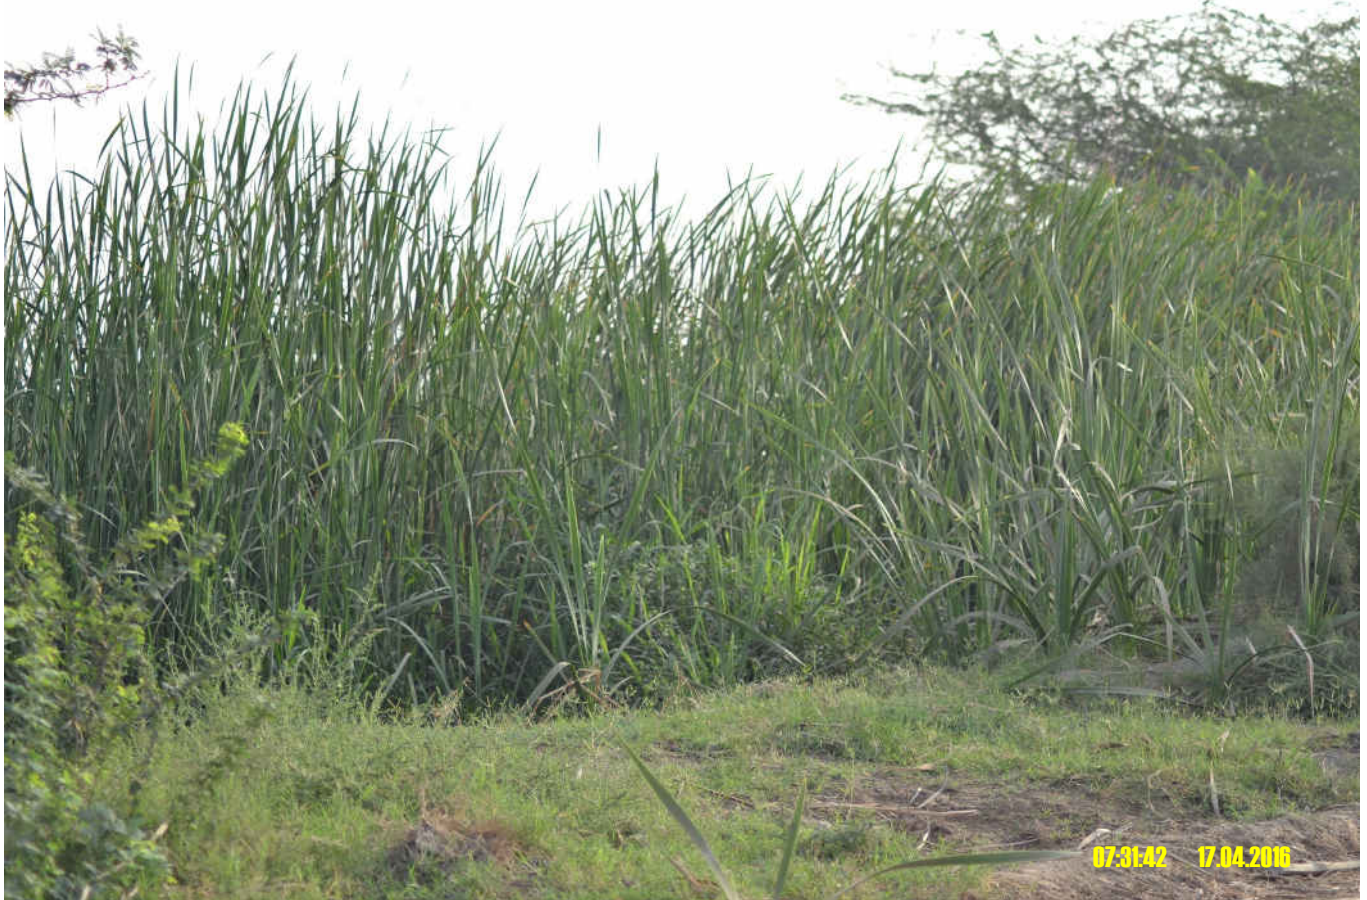
Photo - 1: Undisturbed riparian reeds along Barapullah Drain, Photograph Dated: 17<sup>th</sup> of April 2016

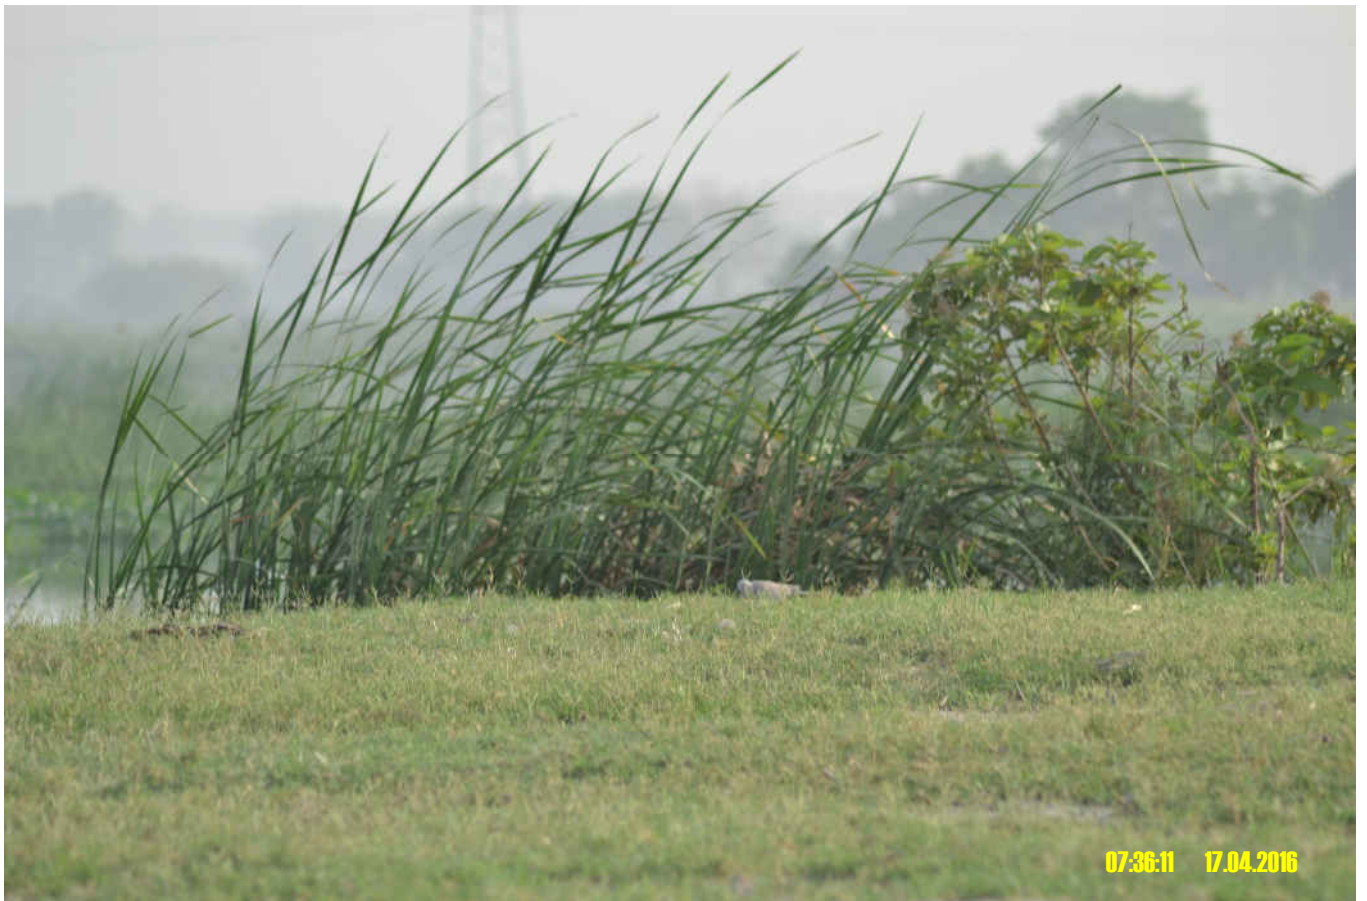
Photo - 2: Undisturbed riparian reeds along Barapullah Drain, Photograph Dated: 17<sup>th</sup> of April 2016

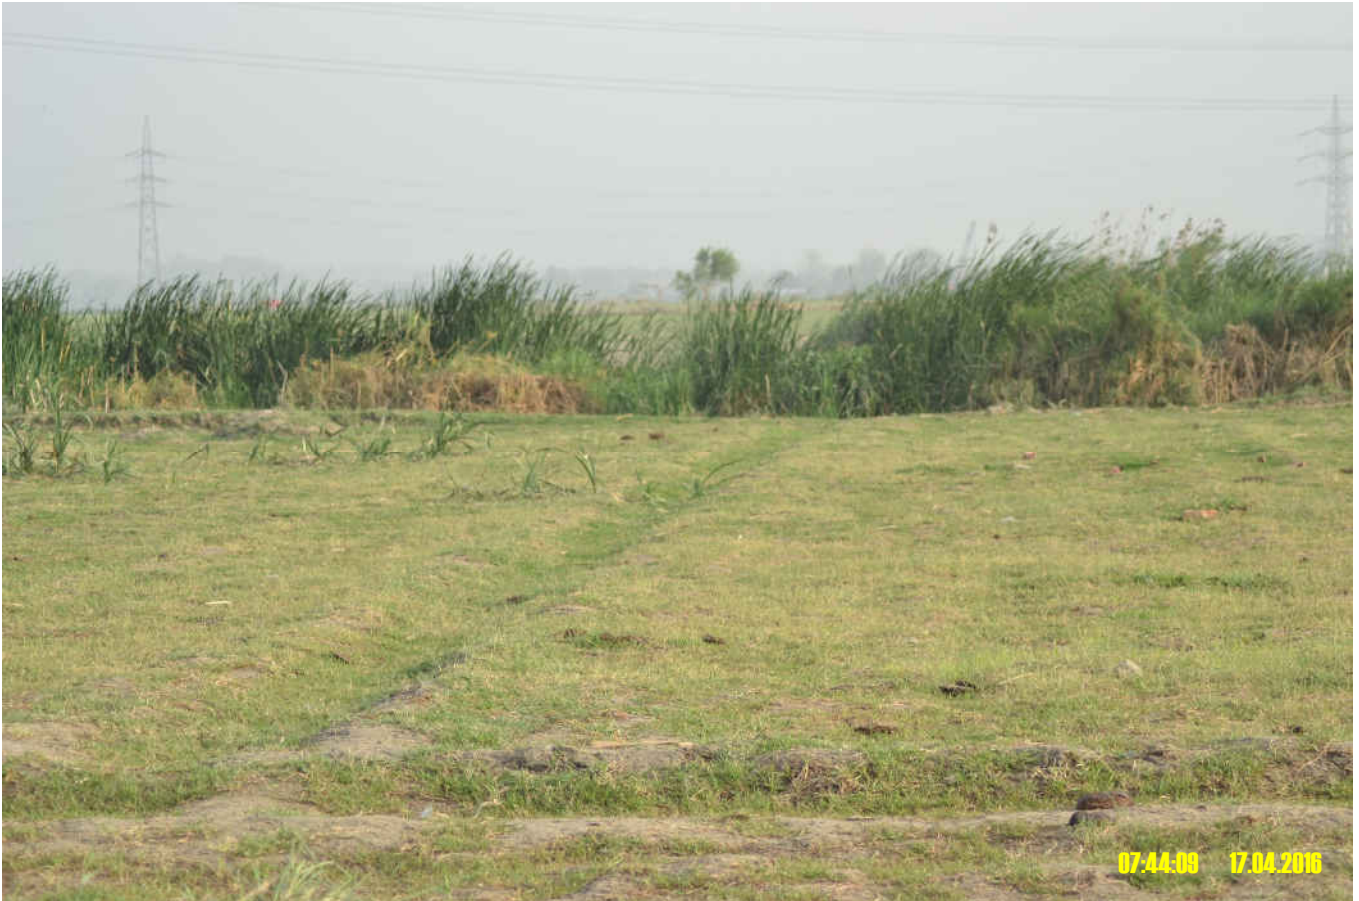
Photo - 3: Undisturbed riparian reeds along Barapullah Drain, Photograph Dated: 17<sup>th</sup> of April 2016

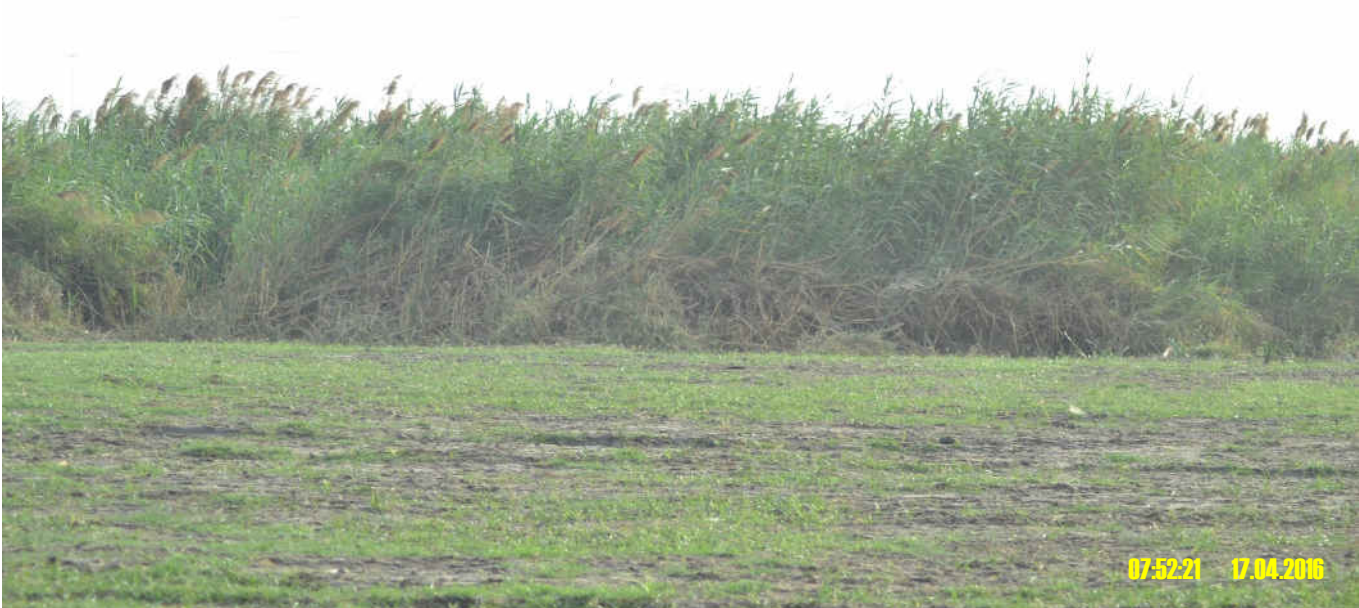
Photo - 4: Undisturbed riparian reeds along Guide Bank on the Land Parcel, Photograph Dated: 17<sup>th</sup> of April 2016

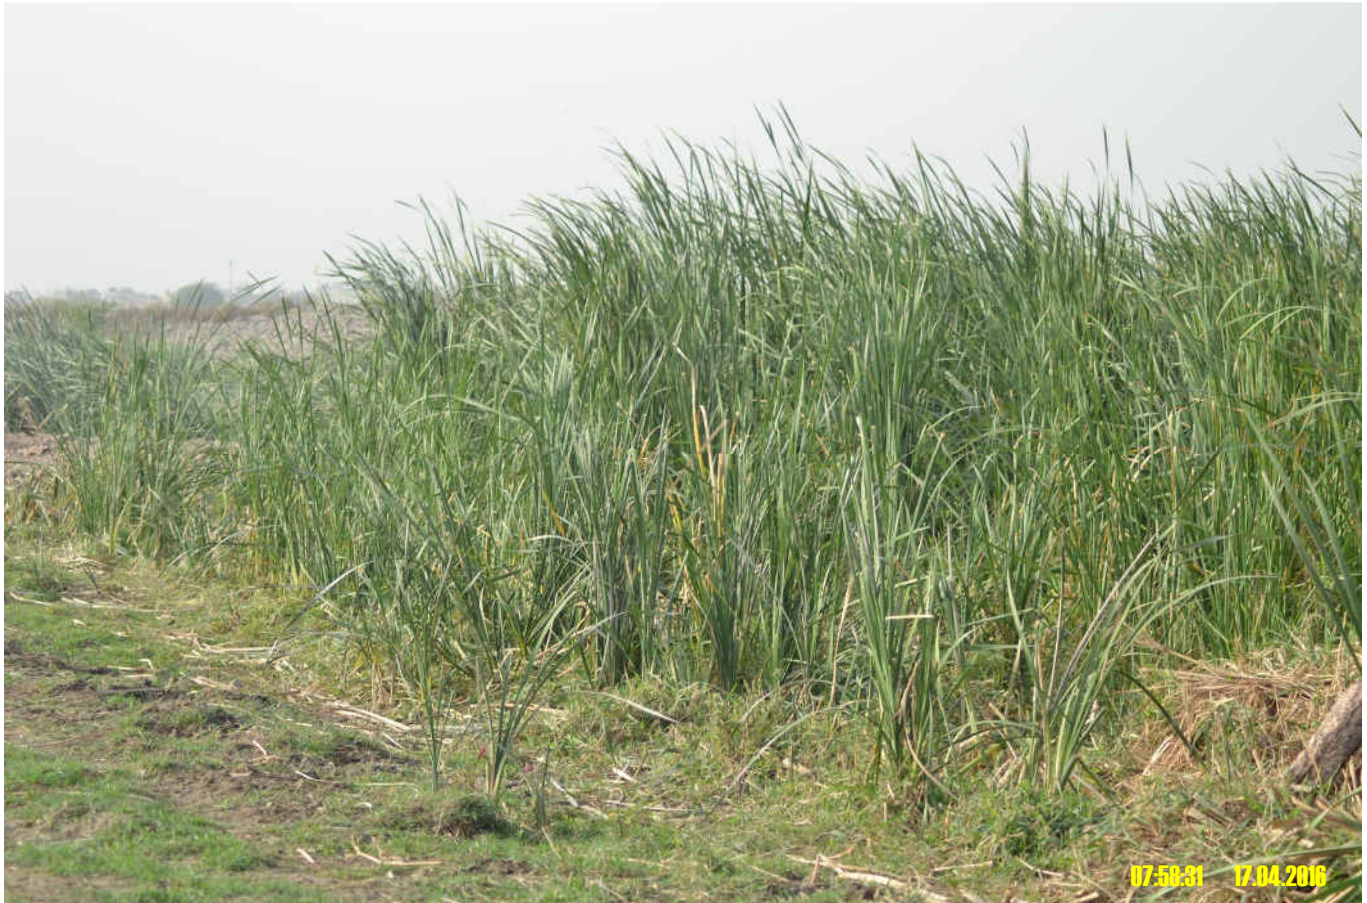
Photo - 5: Undisturbed riparian reeds along the abandoned channel in front of Guide Bank, Photograph Dated: 17<sup>th</sup> of April 2016

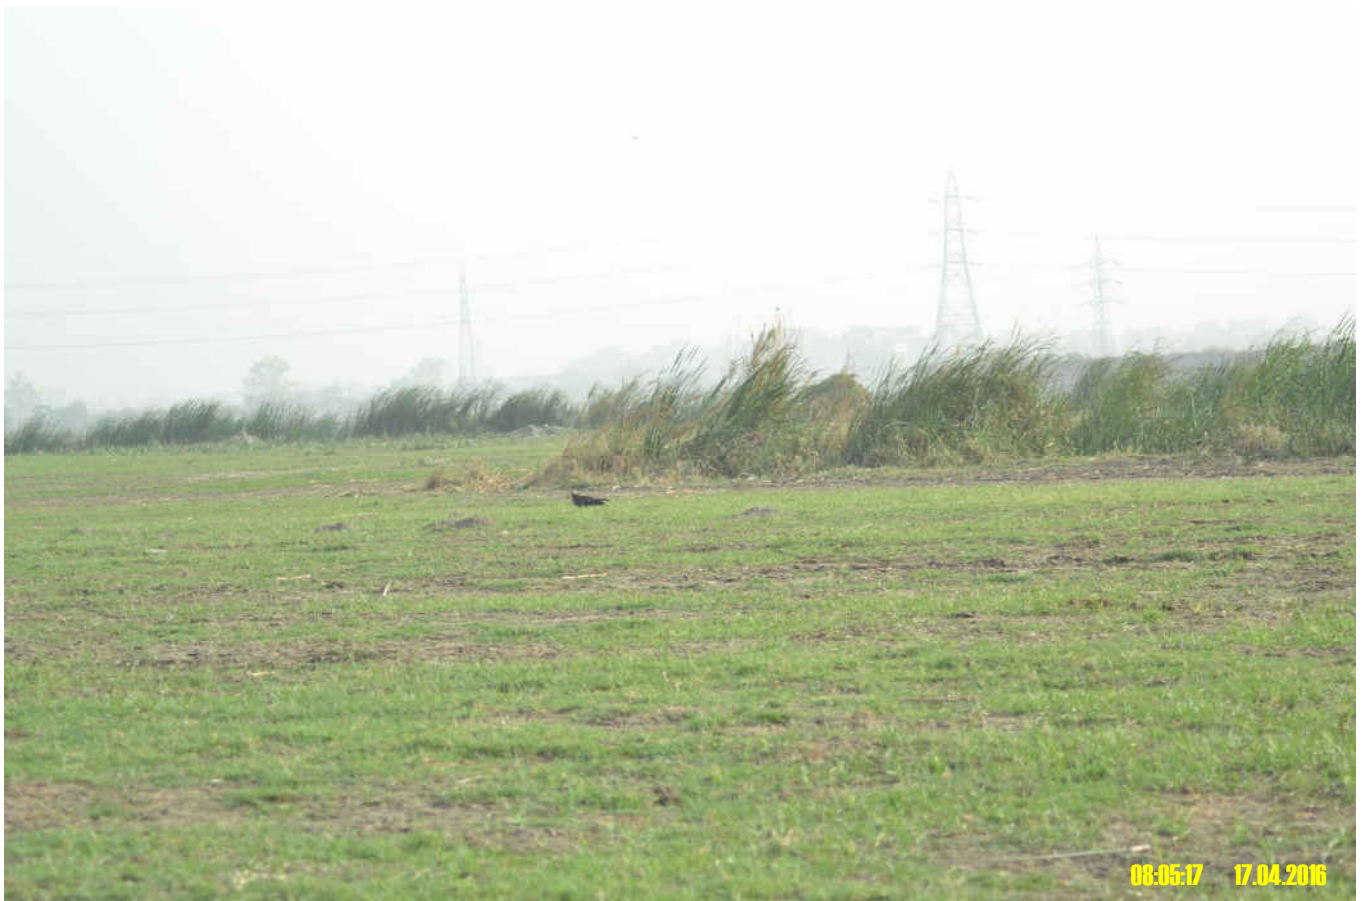
Photo - 6: State of grasses on the event venue, Photograph Dated: 17<sup>th</sup> April 2016

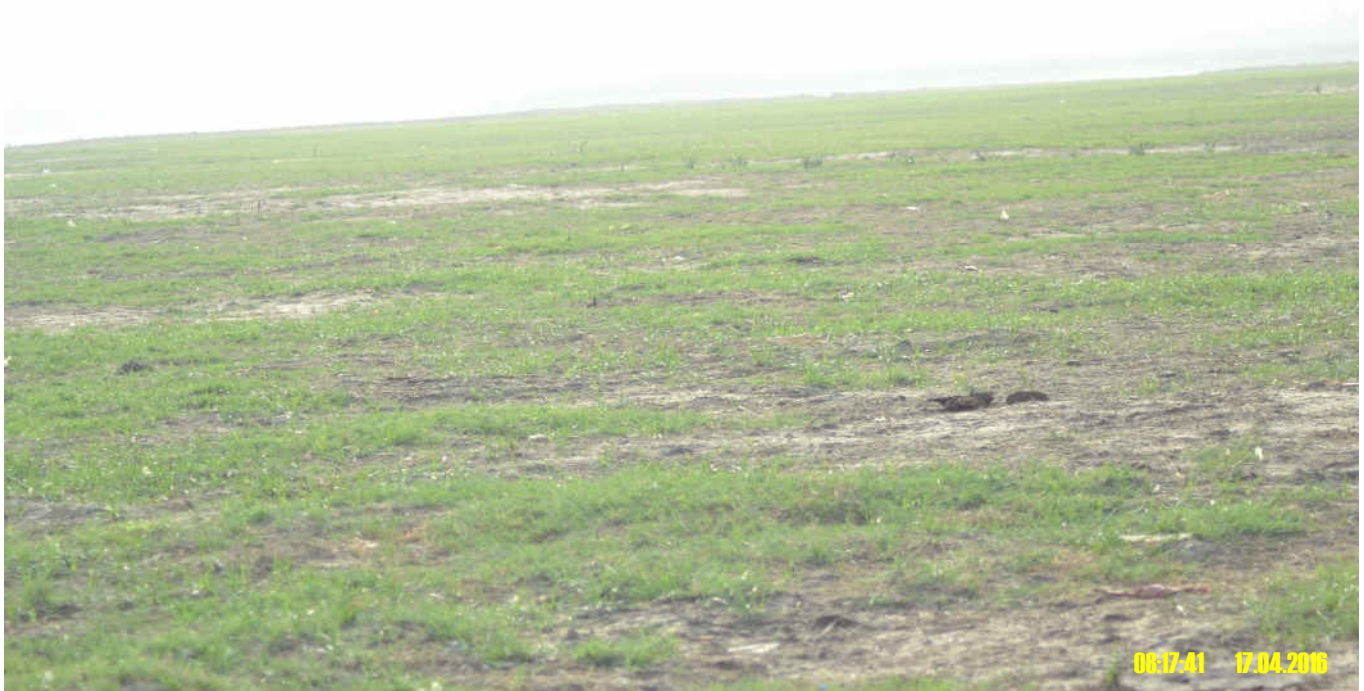
Photo - 7: State of grasses on the event venue, Photograph Dated: 17<sup>th</sup> April 2016

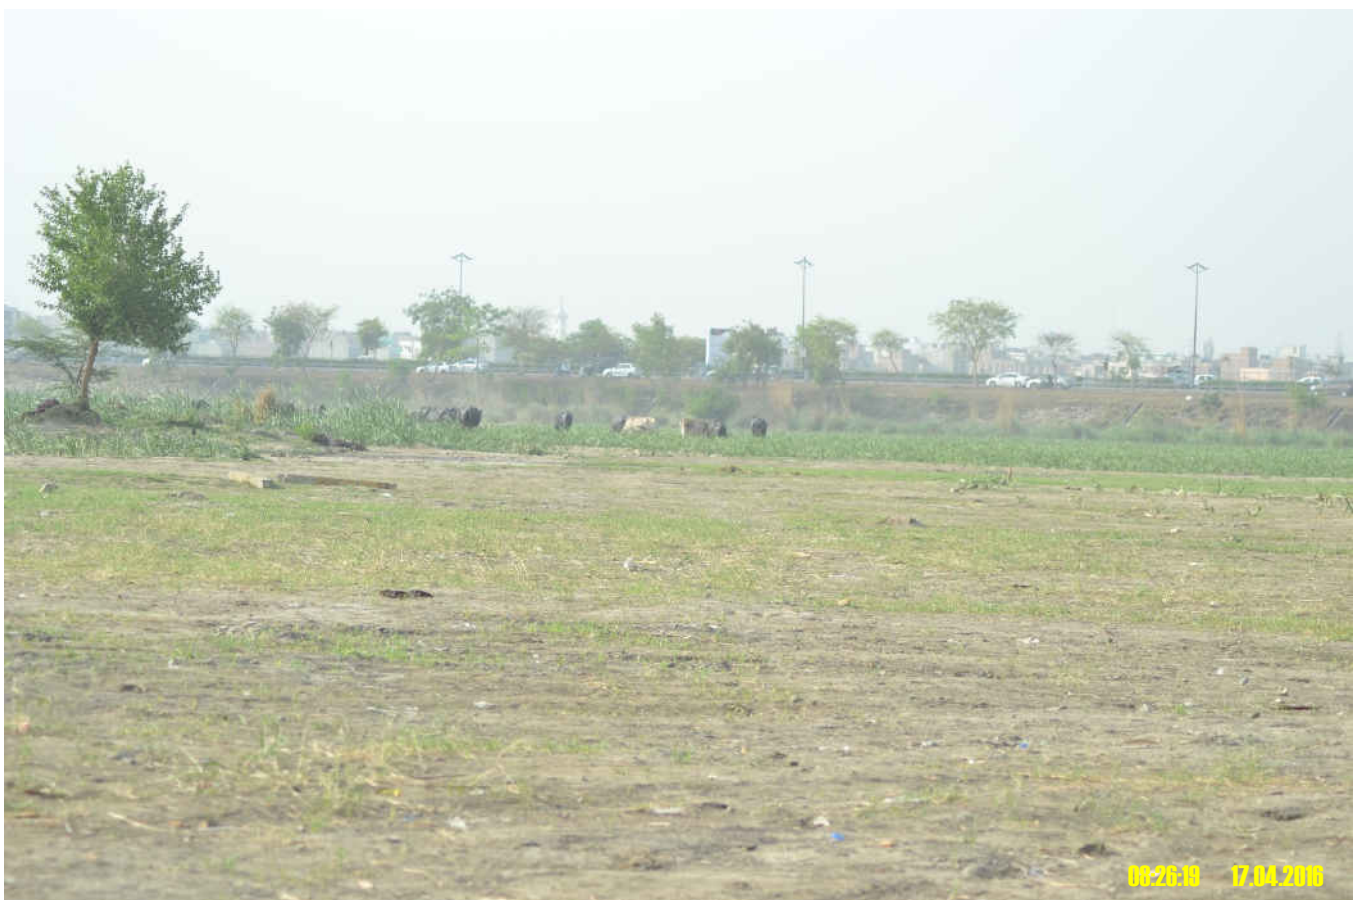
Photo - 8: Regrowth of grasses on over the location where once the stage was raised, Photograph Dated: 17<sup>th</sup> of April 2016

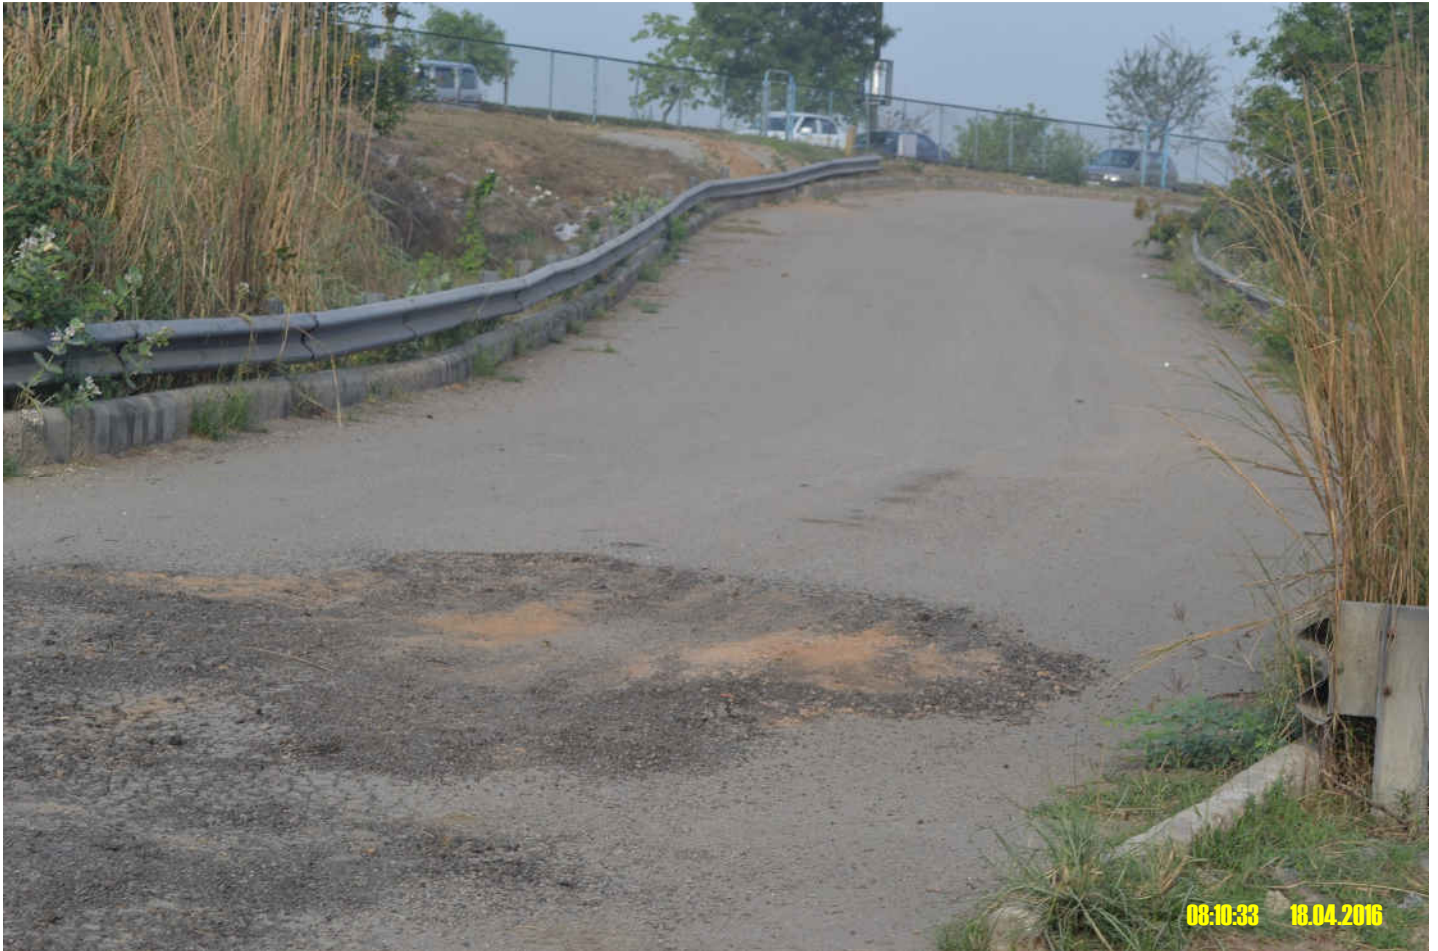
Photo – 1: Permanent Ramp – 1 having bituminous pavement existing at least since January 2008

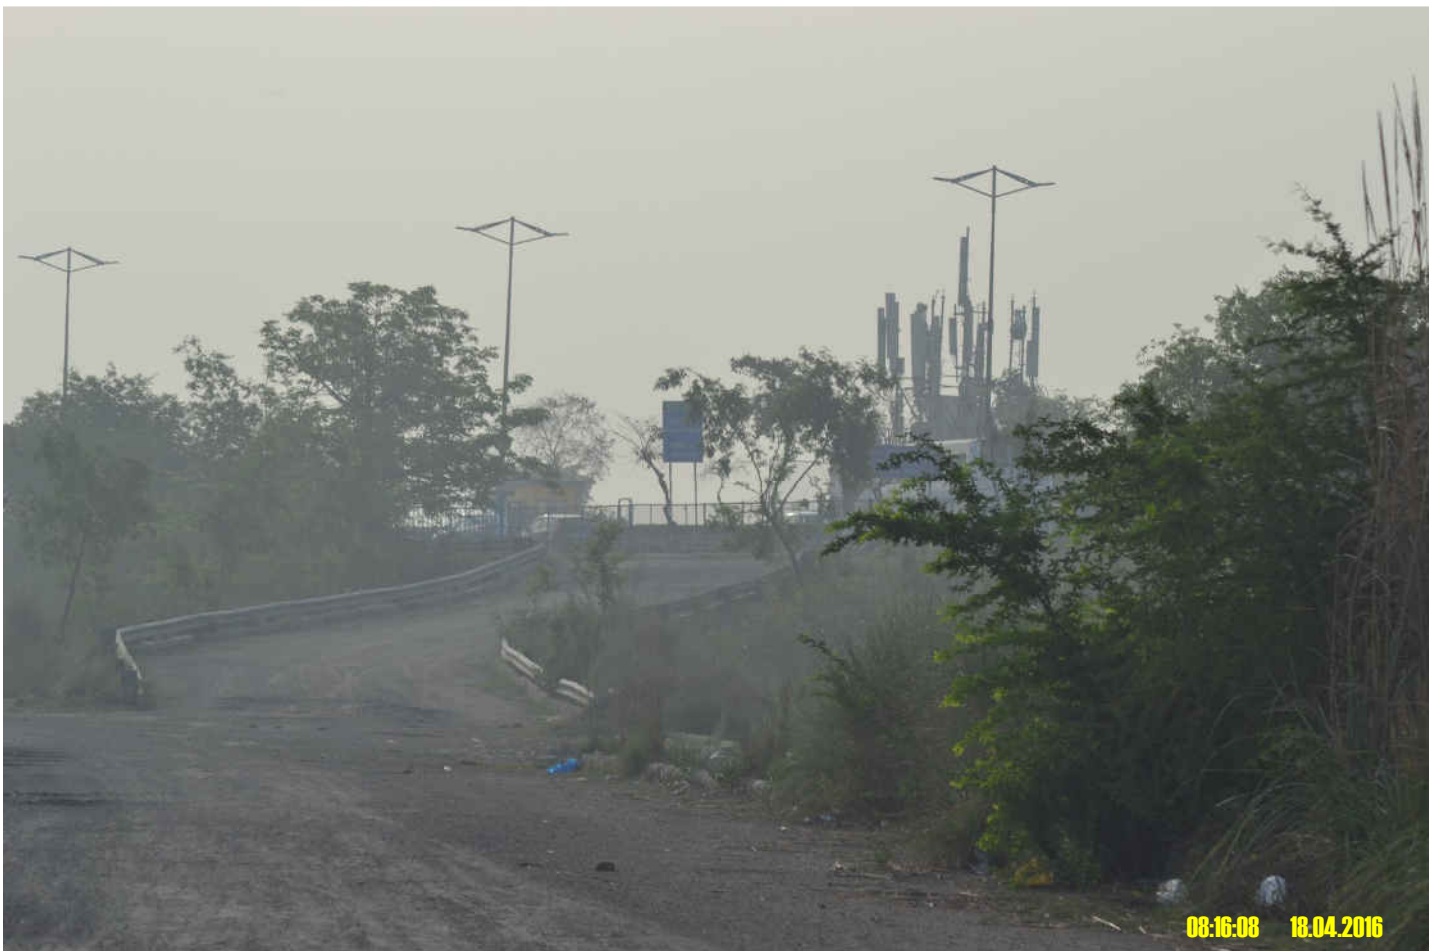
Photo – 2: Permanent Ramp – 2 having bituminous pavement existing at least since January 2008

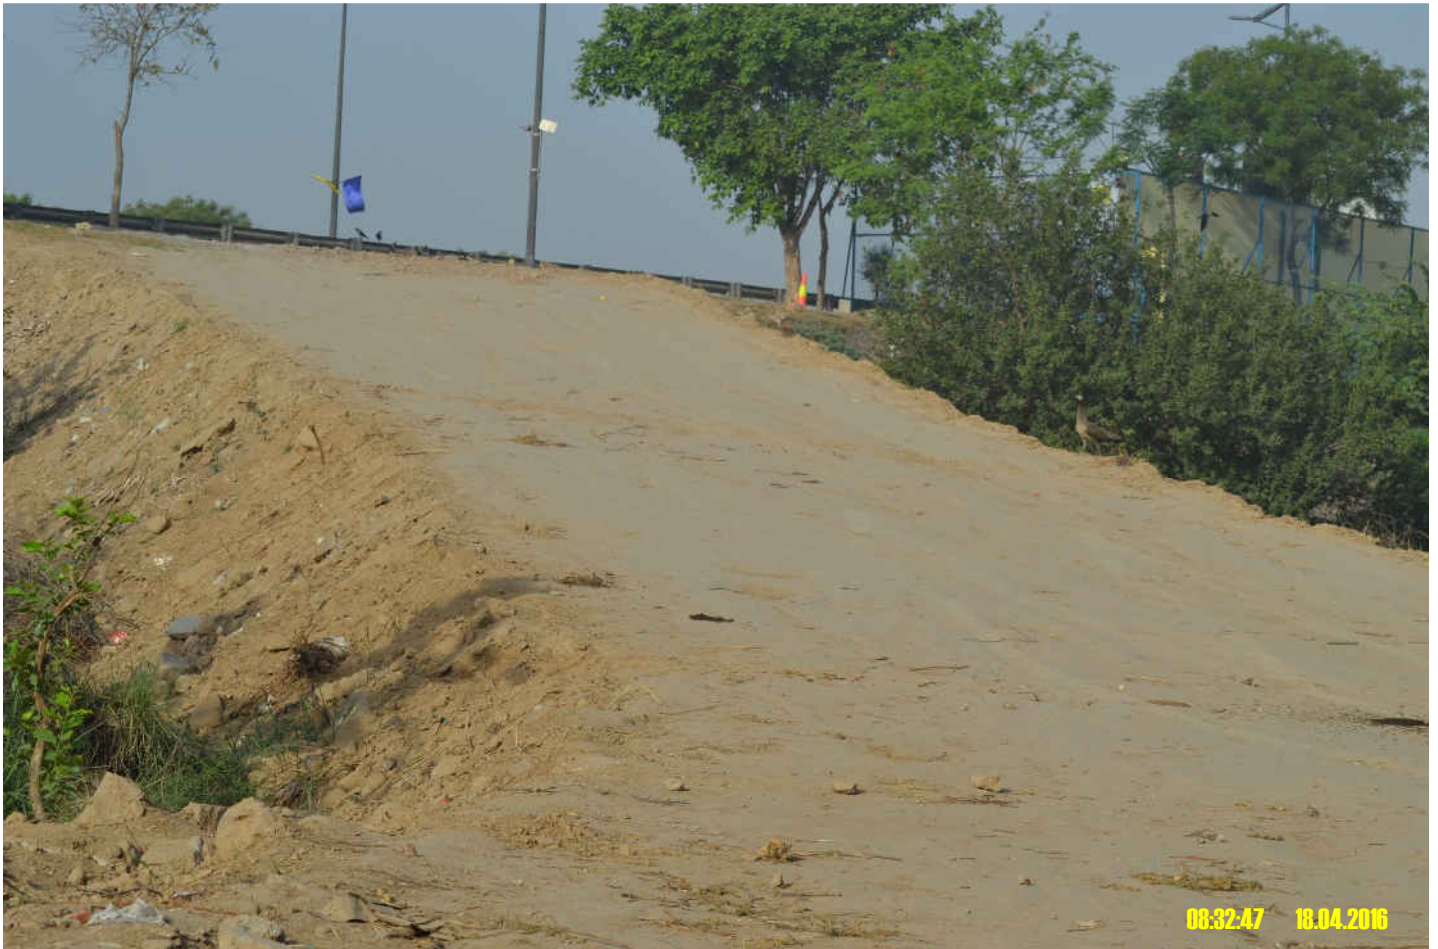
Photo – 3: One of the three earthen ramp constructed over the embankment of DND Flyway for World Culture Festival 2016

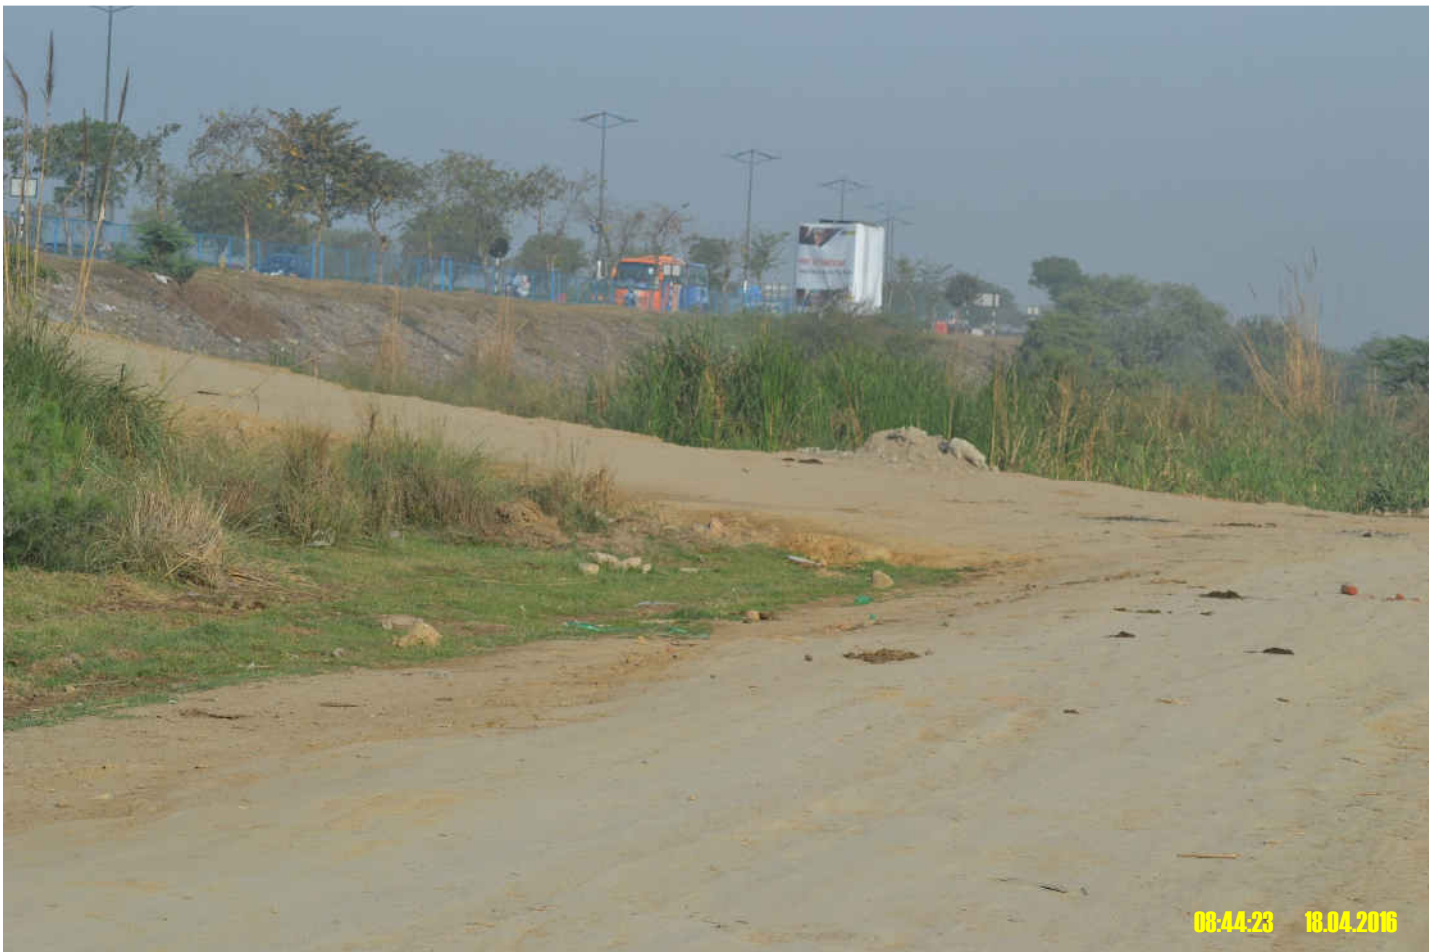
Photo – 4: Second (of the three) earthen ramp constructed over the embankment of DND Flyway for World Culture Festival 2016

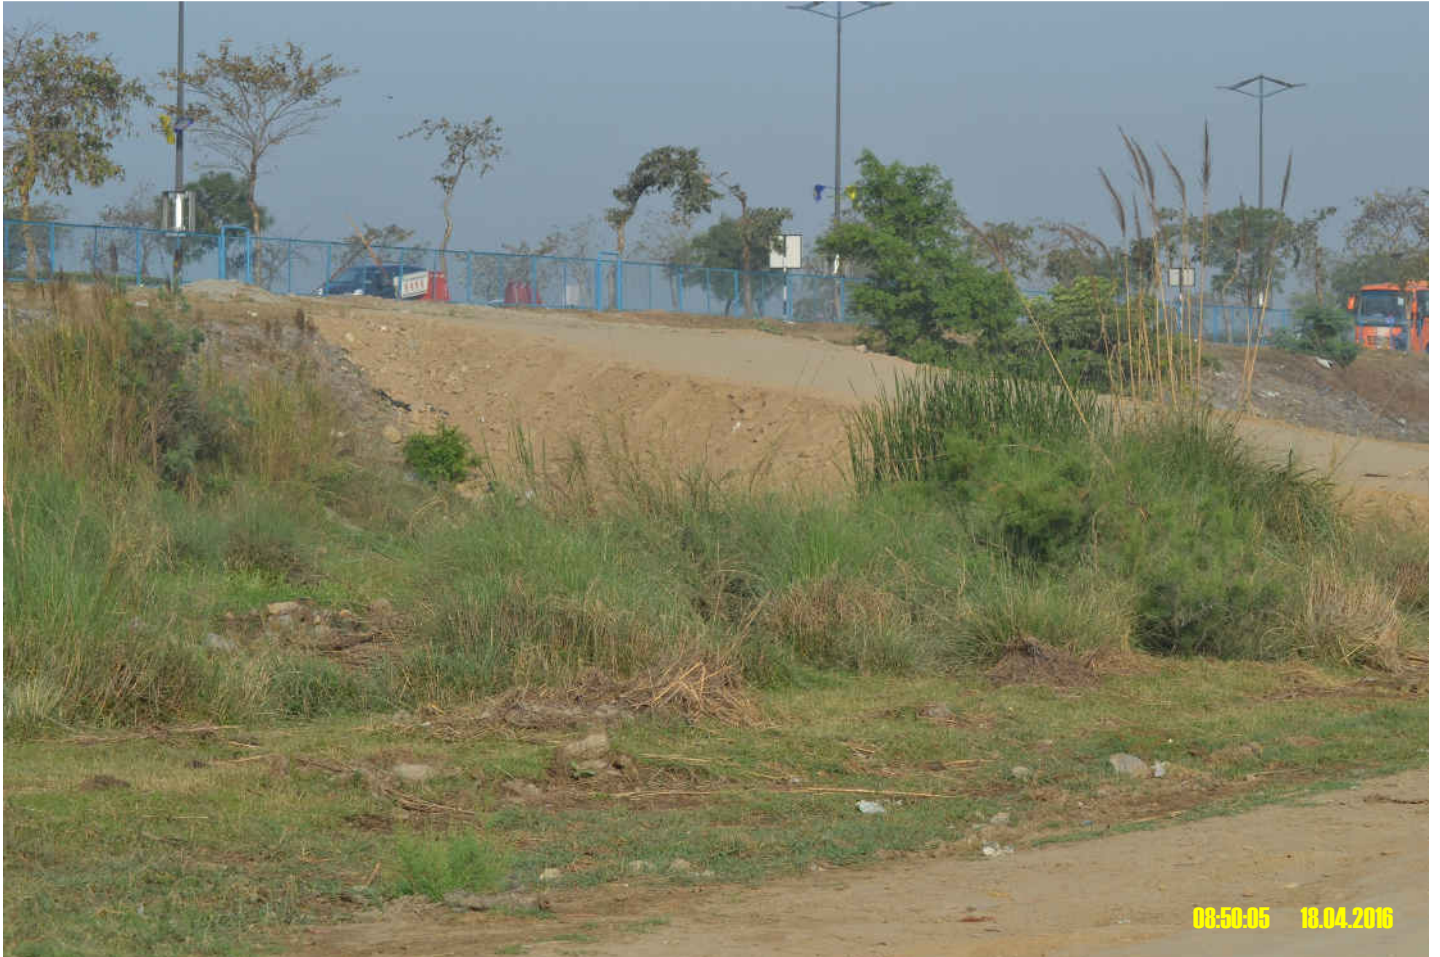
Photo – 5: Third (of the three) earthen ramp constructed over the embankment of DND Flyway for World Culture Festival 2016

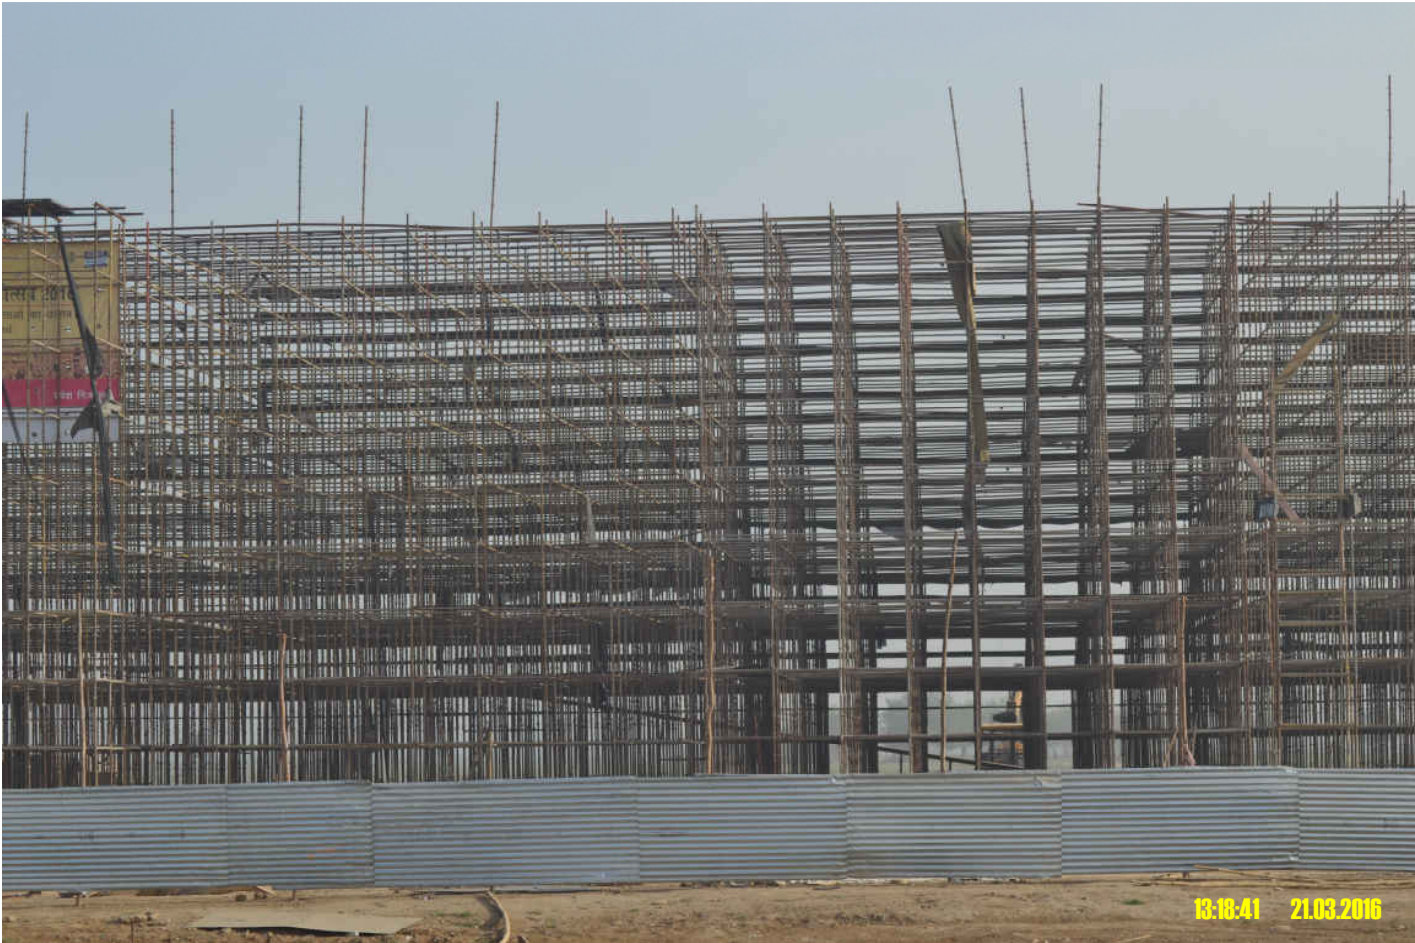
Photo – 1: Scaffolding structure (showing the highest level) used for construction of the stage; photographed during removal of the stage.

- iv. As a matter of fact, this property of dense sand of Yamuna and Ganga makes them valuable material for filling in embankments, and plinth of buildings as inert material in terms of consolidation and/or compaction.
- v. Moreover, it is also important to note that the entire stage for the event was supported on a series of iron scaffolding with raft footing (as illustrated in figure - 2).
