EXPERT REPORT OF Mr. RAKESH RANJANSCOPE:

1. The scope of present study is to conduct a scientific examination of claims and counterclaims of irreversible and/or reversible damages to a land parcel on floodplain of Yamuna due to Art of Living's event, World Culture Festival 2016 which was held between 11<sup>th</sup>, 12<sup>th</sup> and 13<sup>th</sup> of March 2016 (hereinafter referred to as "**Land Parcel**"). This Land Parcel can be delineated over a satellite imagery dated between 10<sup>th</sup> and 17<sup>th</sup> of March 2016 with all its installations and temporary (or permanent) infrastructure. The Land Parcel in this case is a finite portion of land over Yamuna floodplain bound by DND Flyway to its South; Barapullah Drain to its North; River Yamuna to its East and Ring Road to its West and more precisely the core area of activity has been marked over a high resolution satellite imagery available in public domain on google earth, dated 15<sup>th</sup> of March 2016 and it can be located by WGS 84 coordinates 28°34'55"N and 77°16'43"E [screenshot and interpretation are enclosed in **Annexure – I(Colly)**].

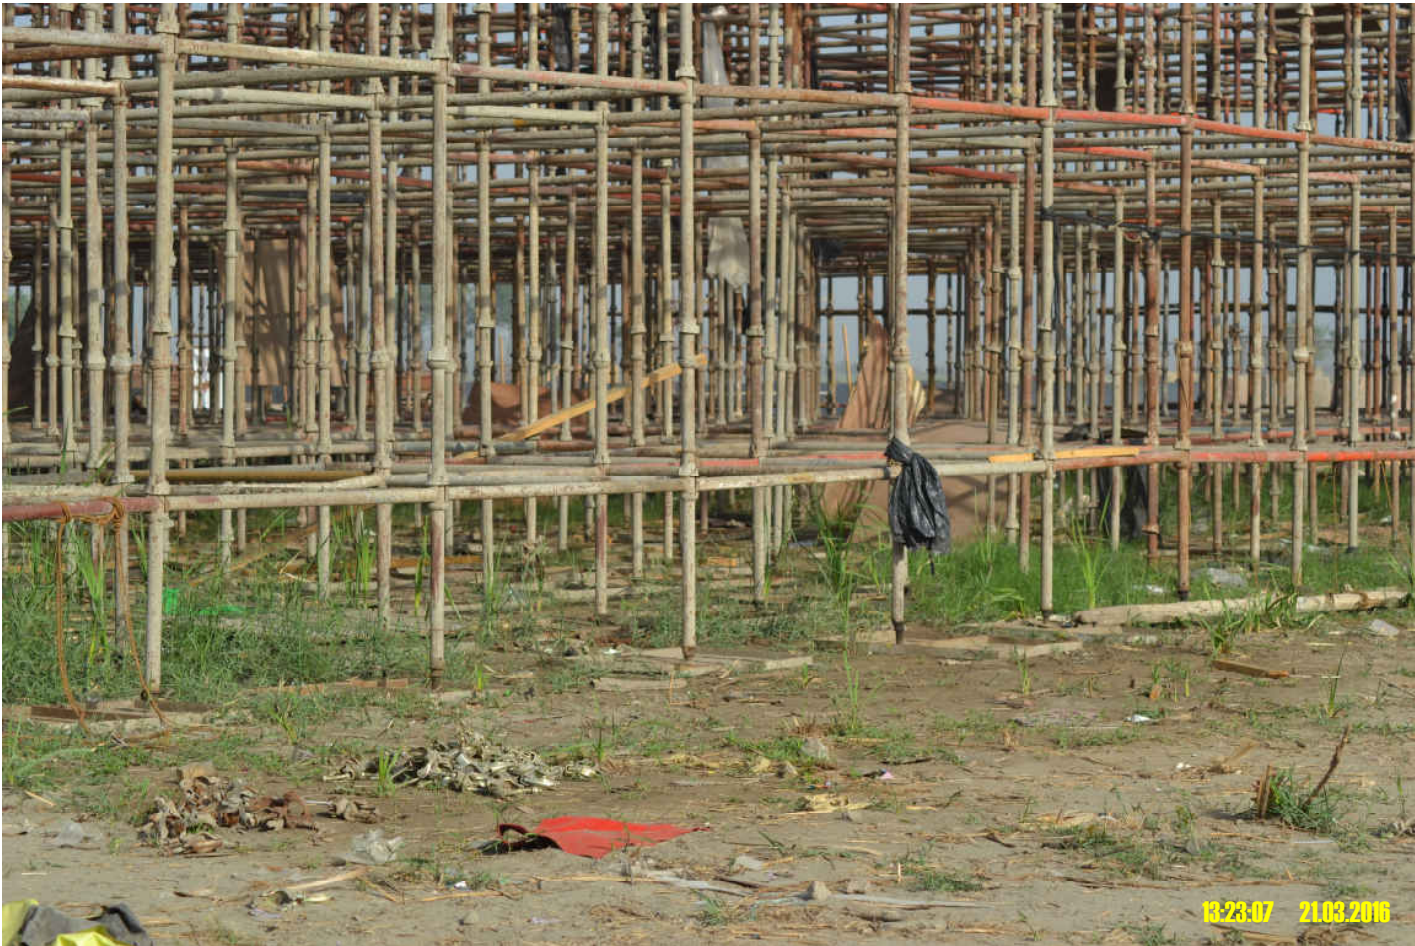
Photo – 2: Steel plate raft used for distribution of load, without any anchorage in the ground; photographed during removal of the stage.

- iv. As a matter of fact, this property of dense sand of Yamuna and Ganga makes them valuable material for filling in embankments, and plinth of buildings as inert material in terms of consolidation and/or compaction.
- v. Moreover, it is also important to note that the entire stage for the event was supported on a series of iron scaffolding with raft footing (as illustrated in figure - 2).

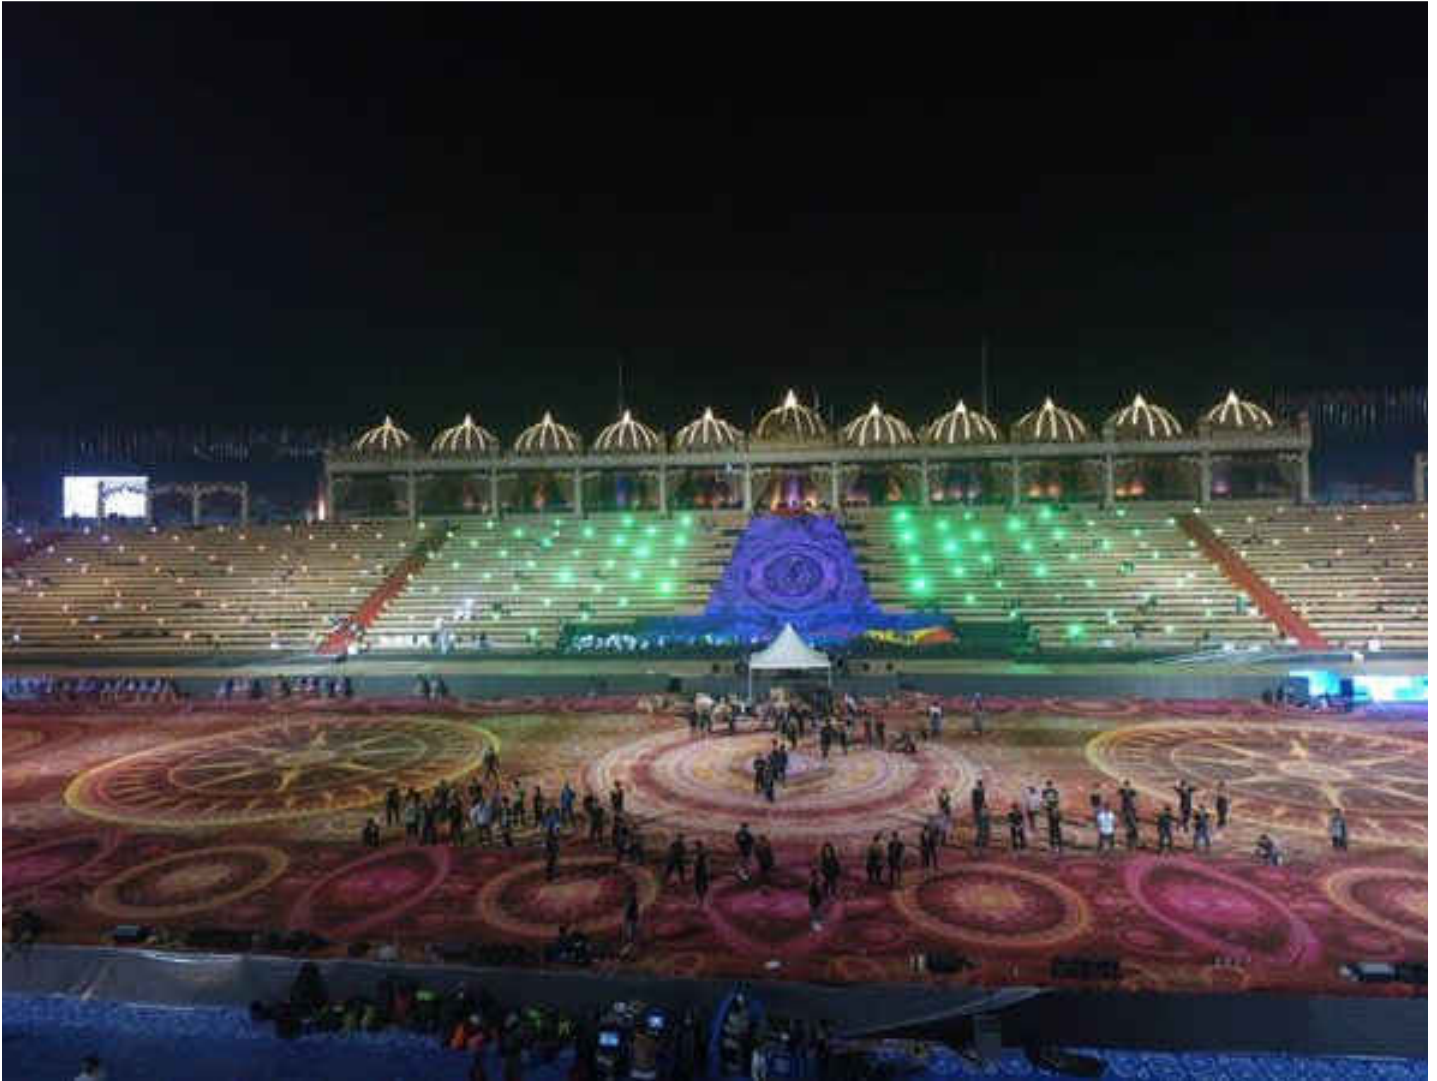
Photo – 3: Photograph of stage resting on scaffolding; the stage was also composed of light weight material.  
(Photograph Sourced from Public Domain)

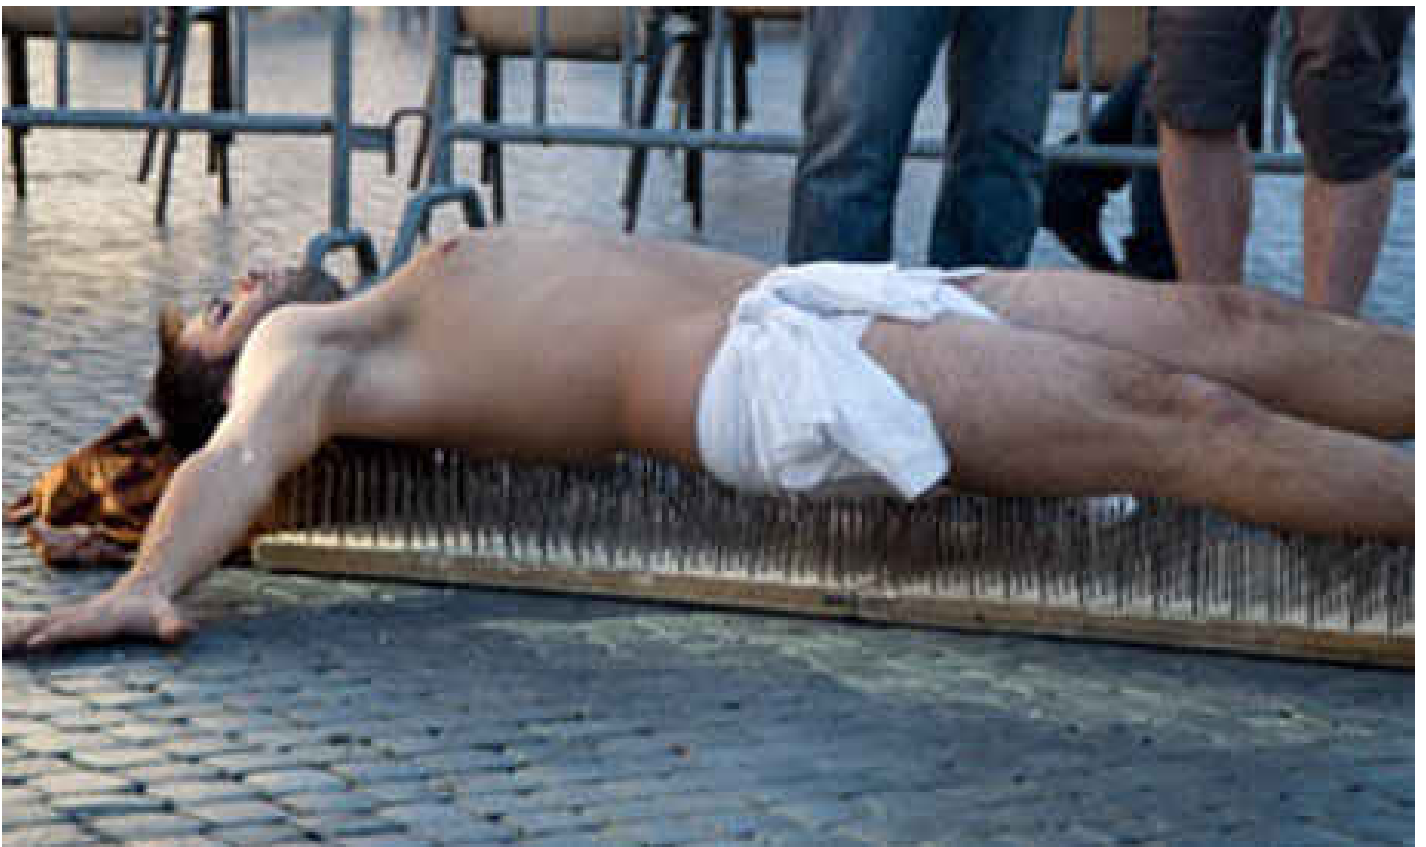
Photo – 4: Concept of 'Yogic Nail Bed' was used in construction of the stage, which is based on the principle of uniform distribution of weight over a large surface area, therefore overall impact is extremely low/negligible.  
(Photograph Sourced from Public Domain)

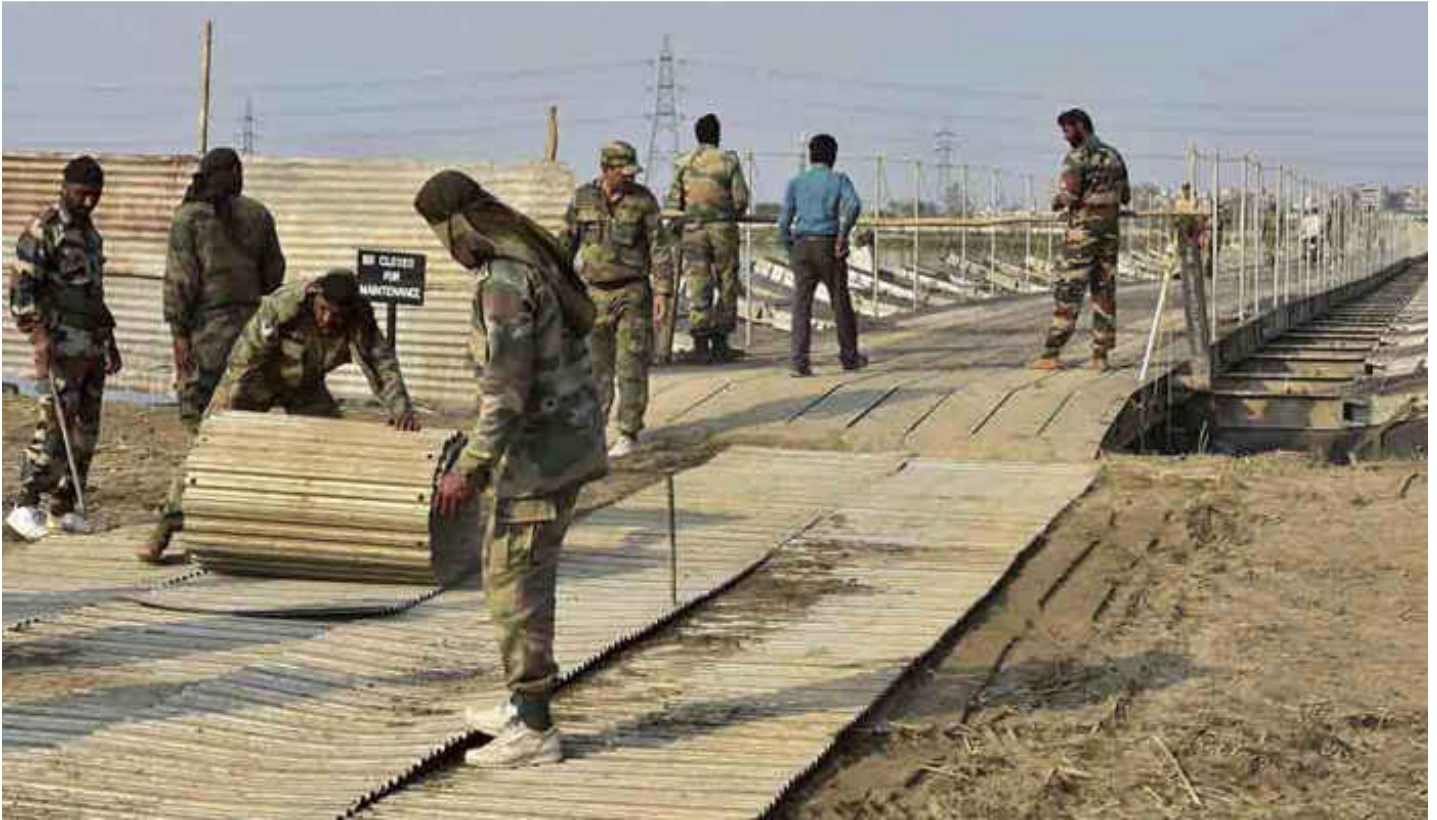
Photo – 1: Laying of Pontoon bridges across Yamuna by trained professionals  
(Photograph from External Source)

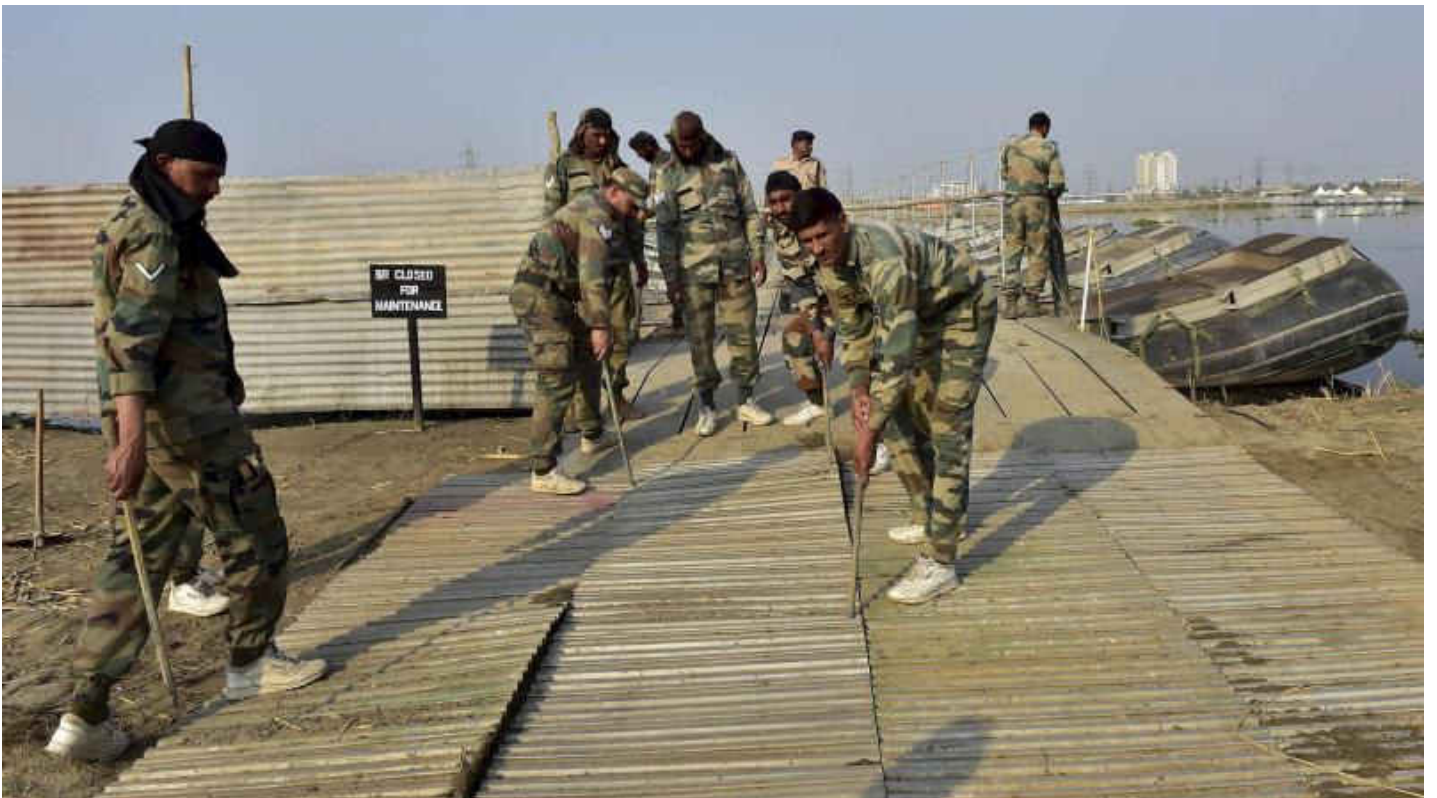
Photo – 2: Laying of Pontoon bridges across Yamuna by trained professionals  
(Photograph from External Source)

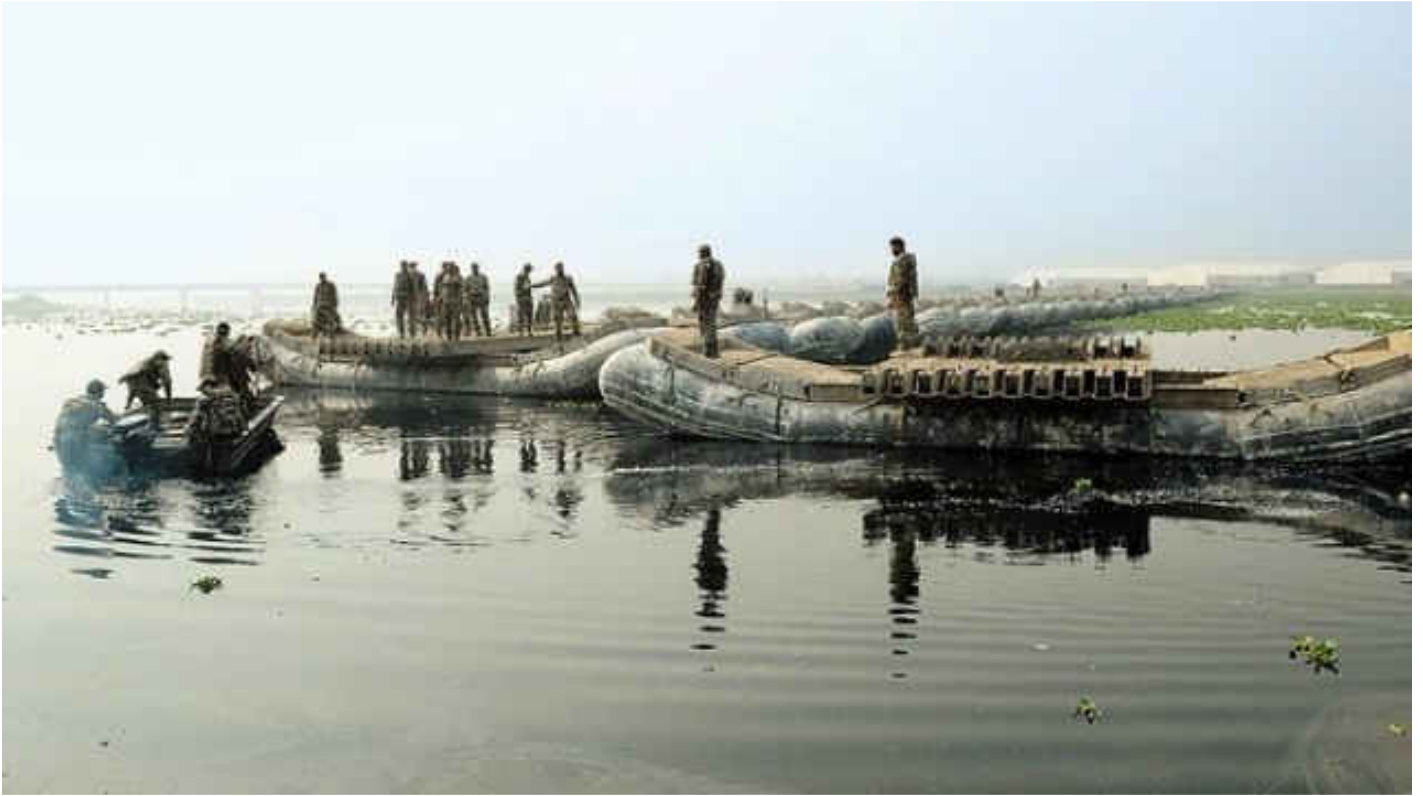
Photo – 3: Laying of pontoon bridges (floating structure) across River Yamuna by trained professionals  
(Photograph from External Source)

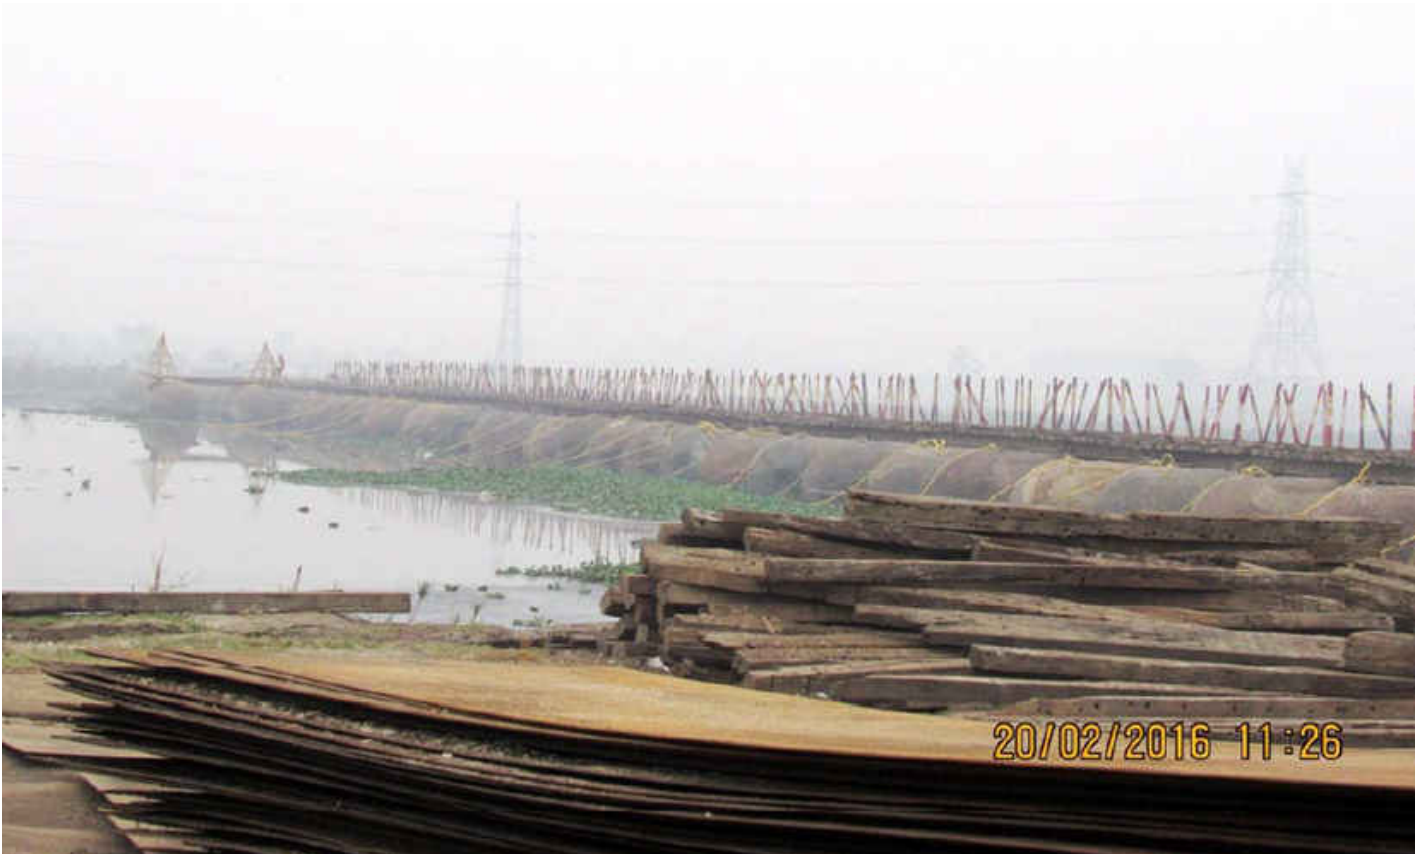
Photo – 4: Laying of first pontoon bridges across Yamuna by trained professionals  
(Photograph from External Source)
